# Analysis and Preservation of Lime-Kilns in Corsica

A. Papalou, K. Vozikis

**Abstract**—The aim of this paper is the analysis and preservation of lime kilns, focusing on the structure, construction, and functionality of vertical shaft lime kilns of the Cap Corse in Corsica. Plans and sections of two lime kilns are presented in detail, providing an overall picture of this specific industrial heritage. The potential damage areas are identified performing structural analysis of a lime kiln using the finite element method. A restoration and strengthening technique that satisfies the directions of the Charter of Venice is presented using post-tensioning tendons. Recommendations are given to preserve and promote these important historical structures integrating them into the custom footpath.

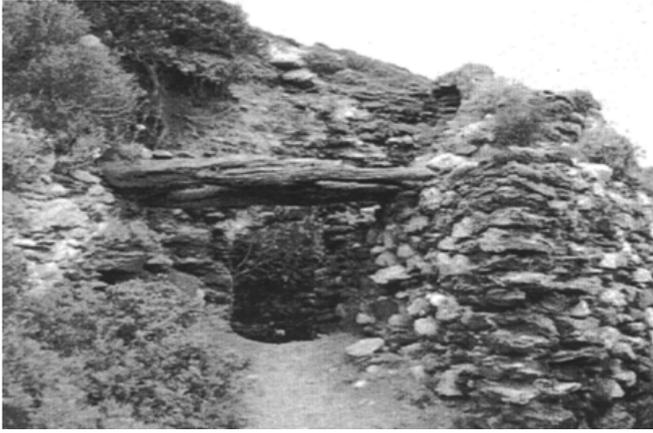
Fig. 3 Lime Kiln 1 as seen from the access path

Fig. 3 shows the condition of the kiln today. While the shaft's cylinder subsists completely at the bottom, large parts have collapsed over time from its top. The remaining kiln's height today measures 5.35 m at its highest point (Fig. 5). Its real height, when in use, cannot be estimated. The firing door opening is 1.65 m tall today. At the same height three wooden beams remain, where probably the foyer's roof was constructed on.

There are still visible lime spots inside and outside the chimney. It was also possible to find the quarry which is located near the kiln. However, no stock house could be found nearby, which leads to the assumption that this lime kiln was used for the construction of the two mills or the expansion of the village of Macinaggio located in a short distance. The lime kiln is visible and easily reachable from the custom footpath. Unfortunately, a fig tree that has grown inside the kiln has started to destroy the masonry, while the outside is covered to a large extent by maquis.

Lime kilns are historical structures of every country's industrial heritage and an effort must be made for their restoration and preservation. This can be accomplished by removing any vegetation that has grown, replacing the mortar and stones that have been fallen or are in poor condition, and strengthening the areas of high stress. Several methods can be considered for increasing the strength of this structure and reducing the danger of future damage. One of these methods is the post-tensioning that has been used to strengthen several historical structures in the past [11]. A significant advantage of this method is its reversibility, keeping the structure in its original form something highly desirable for historical structures according to the directions of the Charter of Venice [12]. In this method stainless steel tendons are placed in any direction needed and are tensed with an initial stress that can

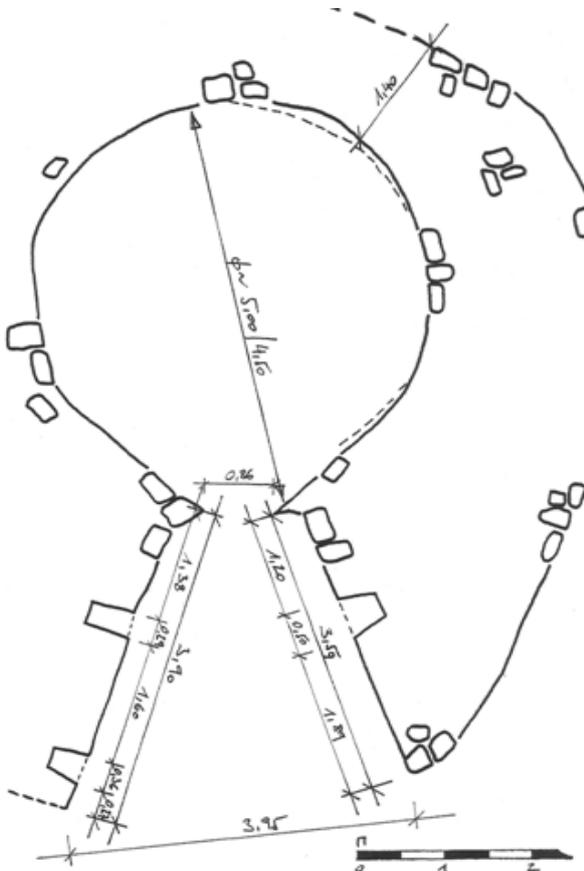
Fig. 4 Ground plan of Lime Kiln 1

This kiln has been partly built adherent to the hillside (almost two thirds of it). The rest of the kiln is constructed of stone walls with mortar. The thickness of the walls varies from 1.4 up to 3.6 m close to the entrance. The inside diameter of the chimney is around 5 m at the bottom (Fig. 4), narrowing gradually and reaching 4.5 m at the top. The entrance foyer of this lime kiln is almost 4 m long. The gate for entering the foyer is also almost 4 m wide, narrowing gradually until the door where the firing occurred. This firing door is today around 0.85 m wide. In this foyer, three 0.5 x 0.5 m niches still exist.

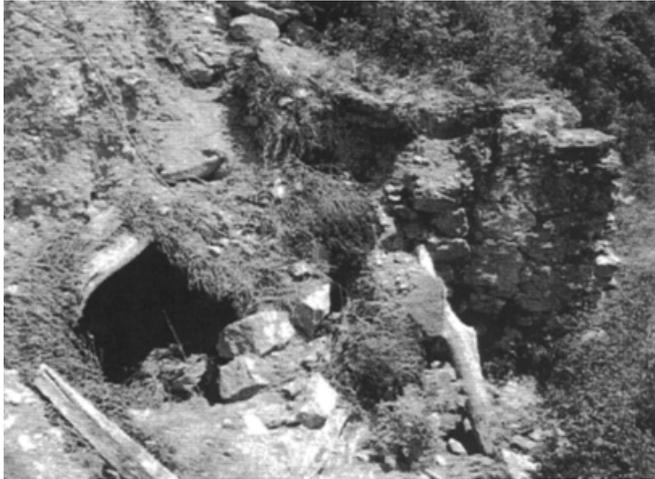
Fig. 6 Lime Kiln 2 as seen from the access path

Lime kiln 2 (Fig. 6) also belongs to the Community of Rogliano and is located next to lime kiln 1. This lime kiln is much smaller than lime kiln 1. The inside diameter of the kiln's shaft measures only 3.6 m, and is constant from bottom to top (Fig. 7). This structure has also been partly built into the hillside. The rest of the kiln form walls built with mortar of 1.15 m wide. An entrance foyer is still visible, but not so well maintained. The entrance width is about 3 m and the distance from the corridor to the firing door almost 4.5 m. The firing door is 0.72 m wide and 1.60 m tall and is better preserved than the previous one (Fig. 8). The firing door dimensions of these two lime kilns are similar, although the shaft's dimensions vary considerably. The shaft of this kiln is in good condition in contrast to the outside part of the foyer. The kiln's height is today approximately 5 m. Two wooden beams still exist at the firing door opening. Lime kiln 2 was probably using the same quarry as lime kiln 1. This kiln is also visible and easily reachable from the custom footpath although its outside part is completely covered by maquis.

Structural analysis was performed on a typical lime kiln using the finite element method. The dimensions used for the model are representative of the dimensions of the lime kilns of Corsica and are based on the dimensions of lime kiln 1. In the finite element model the soil underneath the kiln was considered to extend up to 4 m. The thickness of the soil was 1.5 m at the junction of the thick stone wall with the soil, 10 m in the middle and 4 m next to the entrance (Fig. 9(a)). Extended dimensions of the soil were considered so that the kiln's existence had small influence on the soil at the end of the model where the boundary was considered fixed. A masonry wall of 0.20 m thickness was attached to the soil inside the shaft. Based on observations of the soil and masonry walls of the lime kilns in Corsica, the following properties were used to represent appropriately the materials that compose the lime kilns: the soil's density was  $1800 \text{ kg/m}^3$ , the modulus of elasticity 35 MPa, and the Poisson's ratio 0.24. The masonry's wall density was  $2100 \text{ kg/m}^3$ , the modulus of elasticity 2500 MPa, the Poisson's ratio 0.24, the compressive strength 2.5 MPa, and the tensile strength 0.25 MPa. The materials were considered homogeneous and isotropic. Only dead load was considered. Static analysis was performed using the structural analysis software Ansys. The masonry and the soil were modeled using a 10 node, 3-D solid element. The results are presented in the form of contour plots of the first principal stress (in Pa). Fig. 9(b) shows that the masonry walls are the most stressed parts of the lime kiln. Most of these high stresses are due to the pressure that the existing soil exerts on the masonry structure. In particular, the most stressed areas are the area around the junction of the thick wall with the soil (extended to the thin wall inside the shaft), and the lower part of the thick masonry wall at the entrance. At these areas the stresses exceed the tensile strength of the wall. These results explain the damages appearing on the lime kilns not only in Corsica but elsewhere also (Fig. 6) where the stones have fallen inside the shaft and the entrance wall has been destroyed.

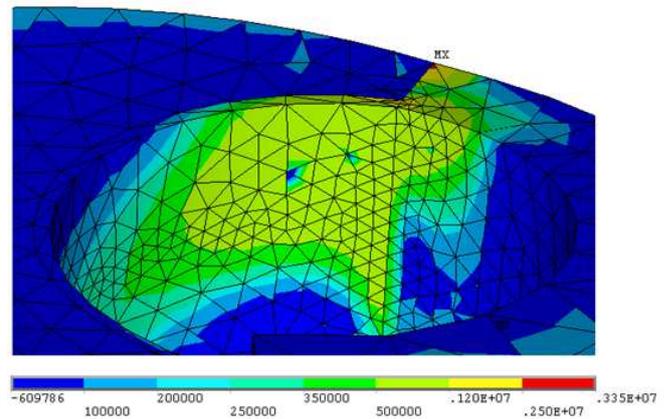
Fig. 10 Close-up of the first principal stress (in Pa) around the junction of the thick stone wall with the soil after using post-tensioning at certain locations inside the shaft

performing finite element analysis on the same lime kiln model considered earlier. A few tendons were applied inside the shaft to tie the thin wall with the soil. The steel tendons used were modeled in Ansys using link elements and had the following properties: modulus of elasticity of 180 GPa, Poisson's ratio of 0.3, total area of 800 mm<sup>2</sup>, and initial strain of 0.00028. Fig. 10 shows the principal tensile stresses at the junction of the stone wall with the soil with the steel tendons. The existence of the tendons reduces drastically the stresses at the area around the tendons. All high tensile stresses will be reduced as more tendons will be applied to tie the stone wall to the soil securely.
