# The Significance of the Radiography Technique in the Non-Destructive Evaluation of the Integrity and Reliability of Cast Interconnects

Keshav Pujeri, Pranesh Jain, and Krutibas Panda

#### IV. CASE STUDY OF AN INTERCONNECT FAILURE IN THE FIELD

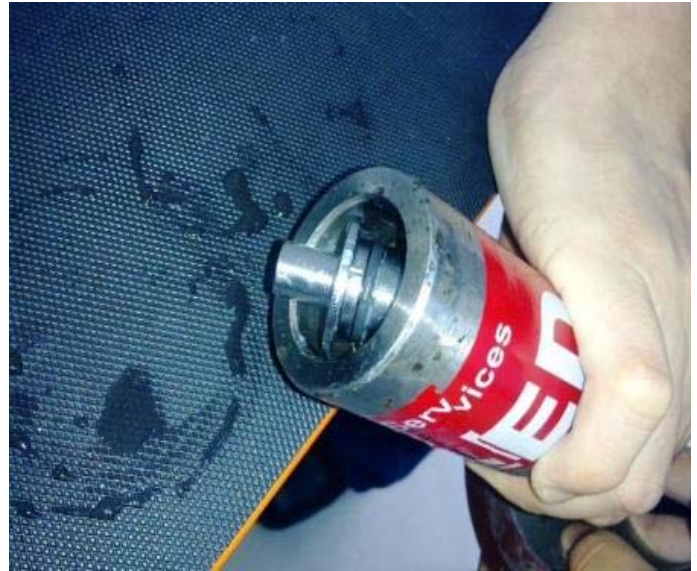
When internal parts of the interconnect assembly were removed; traces of drilling fluid were observed which could have caused the electrical failure (Fig. 3). Further visual inspection of the interconnect revealed a deformity at the inner neck area close to the wire-way. When combined with the evidence of the drilling fluid, we suspected that there was a casting defect in the interconnect body. This defect could have been exposed after the downhole run and drilling fluid would have leaked into wire-way (Fig. 4).

Fig. 3 Leakage inside the connector

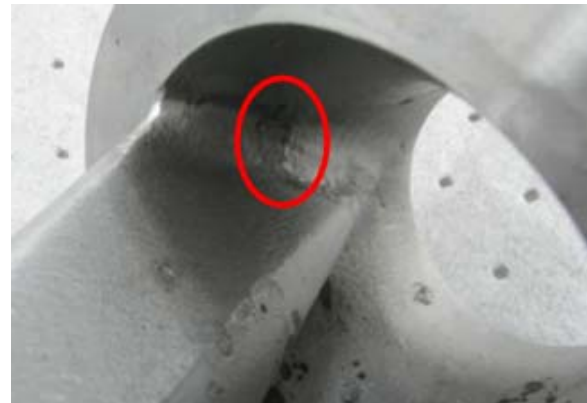
Fig. 4 Suspected casting defect area

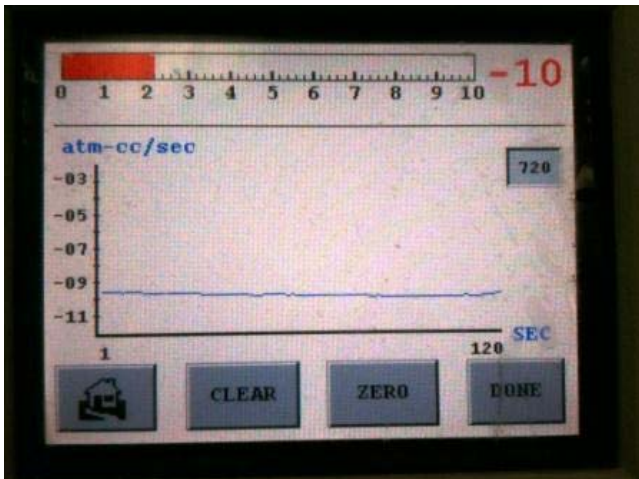
The component was tested for Helium leak with appropriate sealing and fixtures; the leak graph showed no spikes on the sensor/detector monitor (Fig. 5). Hence HLT couldn't detect any defect with the failed interconnect.

Fig. 5 Graph: Rate of Helium leak v/s time

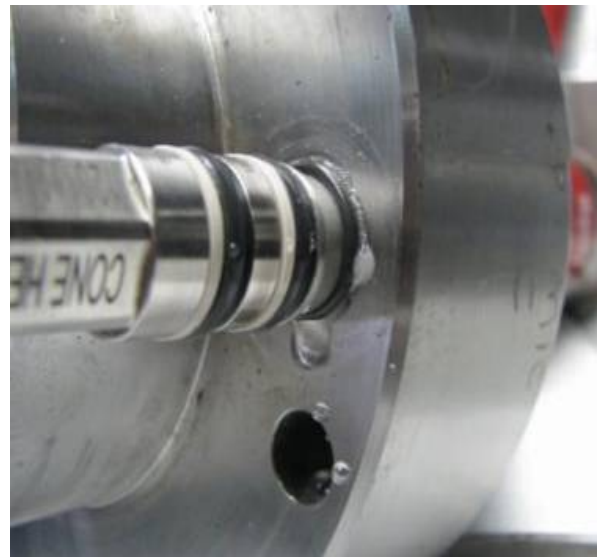
The interconnect was tested three times by applying pressure of 25 ksi twice and 30 ksi once for about 30 minutes each time. We saw that the component had leaked water droplets after the pressure test fixtures were removed but that the fixtures didn't have water drops on them, indicating that the leakage probably did not occur from the fixture side (Figs. 6 and 7).

Fig. 6 Gas escapes while removing fixture

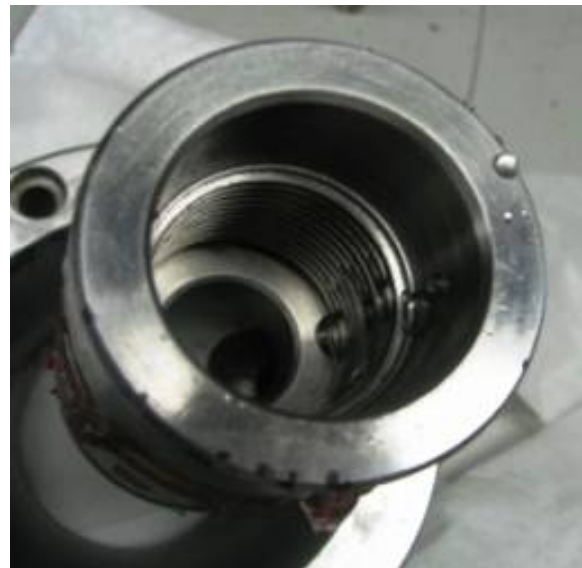
Fig. 7 Water droplets leaked deep in interconnect

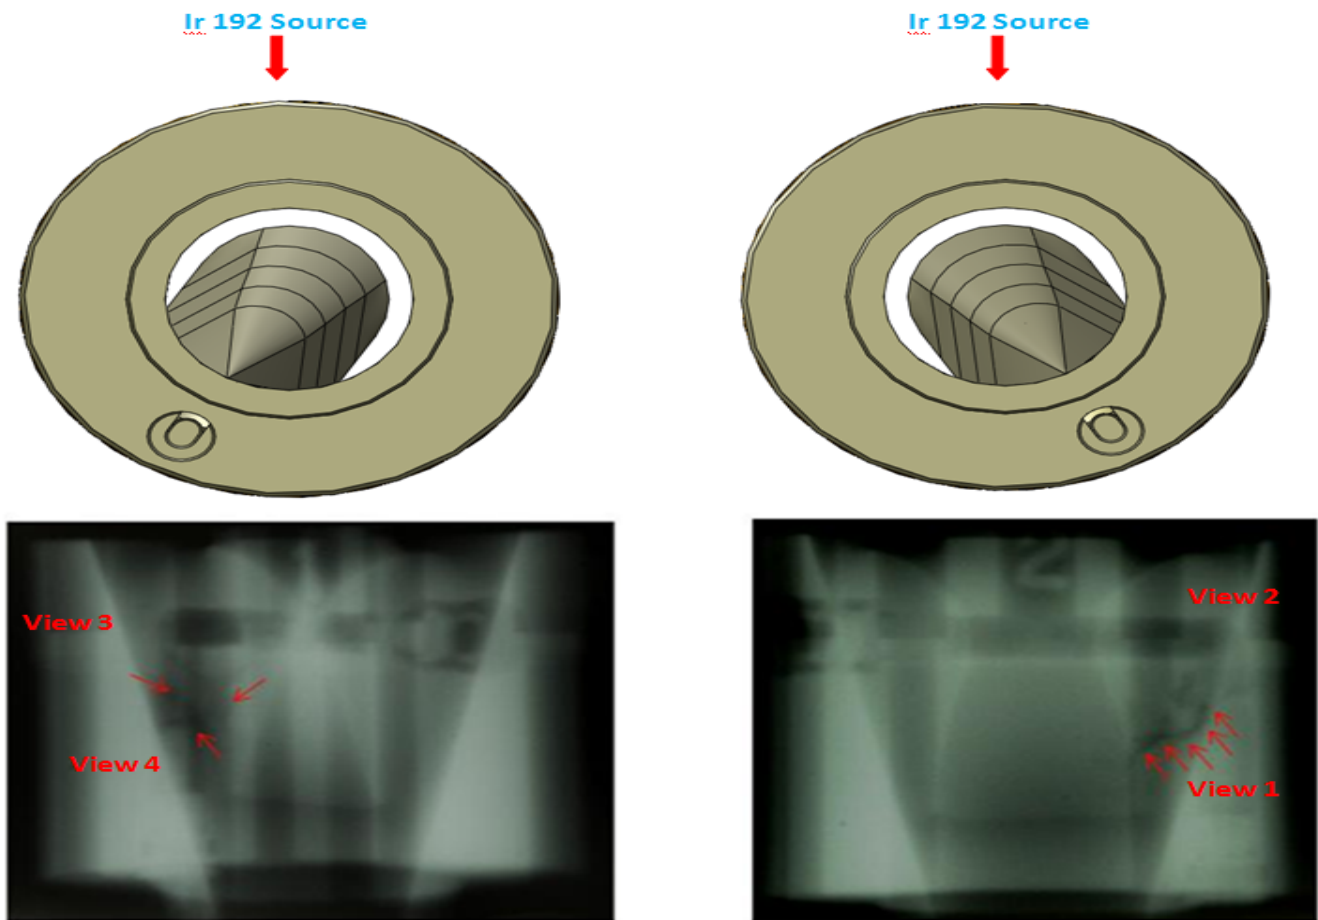
A radiography test was conducted on the component as per ASTM standard E1742/ E1742M [5]. Iridium-192 was used as the source of the gamma rays. The images were captured on radiography films and compared with standard ASTM Radiographs E446-10 [3]. The nature and intensity of the contrasting areas on the radiographs led to the conclusion that the defect was shrinkage porosity type 'CB' and severity level '3' (Fig. 8).

Fig. 8 Radiography test on the defect interconnect

Based on the radiography results, the mold design was improved by introducing a new gating system. Additionally, radiographic inspection was added to test all components in 'as cast' condition irrespective of their class; as testing each component is much less expensive than a down-hole failure.

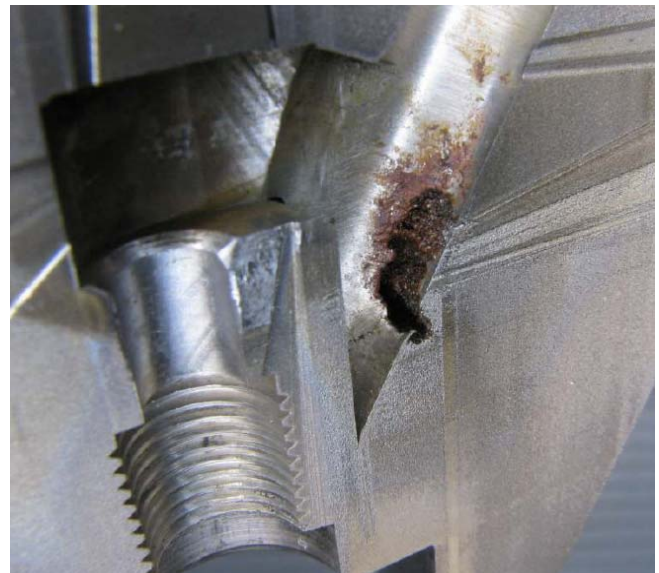
The component was sectioned into two halves by Electric Discharge Machining (EDM) and further metallurgical characterization studies were performed. Cross-sectional analysis near the defect location indicated a hole with brown residue surrounding it as illustrated in Fig. 9. High-resolution electron micrographs at this location indicated solidification of the dendrite structure as shown in Fig. 10. This is indicative of a shrinkage defect. Energy dispersive X-ray spectroscopy performed on the brown residue surrounding this defect indicated a significant presence of carbon, likely grease or oil residue near the defect. The shrinkage porosity was not isolated to a small area but was rather spread across the entire thickness as seen in certain cross-sectional views (Fig. 11).

Fig. 9 Cavity found at defect location

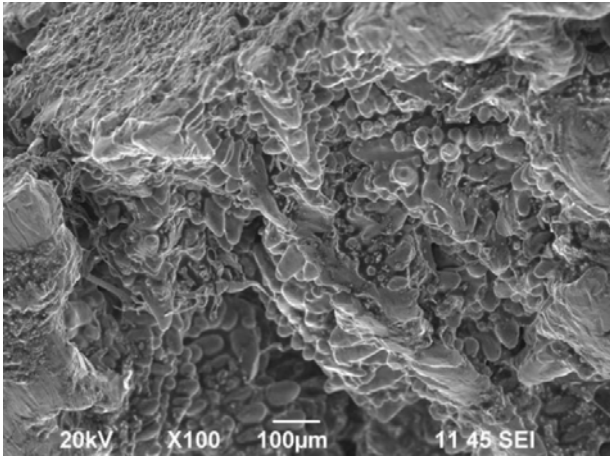
Fig. 10 Microscopic view of the dendrite structure at the shrinkage

In summary, the metallurgical characterization identified the location of the defect and high-resolution microscopy confirmed that the defect was a result of shrinkage porosity. The shrinkage porosity was found to occupy a comparatively larger volume fraction.

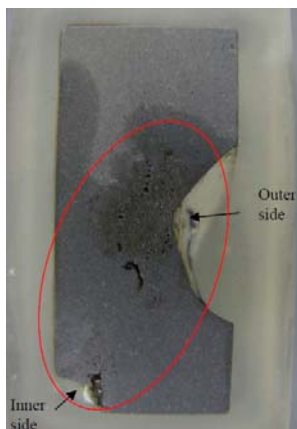
Fig. 11 Cross-sectional view illustrating the shrinkage porosity through the thickness of the interconnect wall
