Assessment of Rehabilitation Possibilities in Case of Budapest Jewish Quarter Building Stock

Viktória Sugár, Attila Talamon, András Horkai, Michihiro Kita

Abstract—The dense urban fabric of the Budapest 7th district is known as the former Jewish Quarter. The majority of the historical building stock contains multi-story tenement houses with courtyards, built around the end of the 19th century. Various rehabilitation and urban planning attempt occurred until today, mostly left unfinished. Present paper collects the past rehabilitation plans, actions and their effect which took place in the former Jewish District of Budapest. The authors aim to assess the boundaries of a complex building stock rehabilitation, by taking into account the monument protection guidelines. As a main focus of the research, structural as well as energetic rehabilitation possibilities are analyzed in case of each building by using Geographic Information System (GIS) methods.

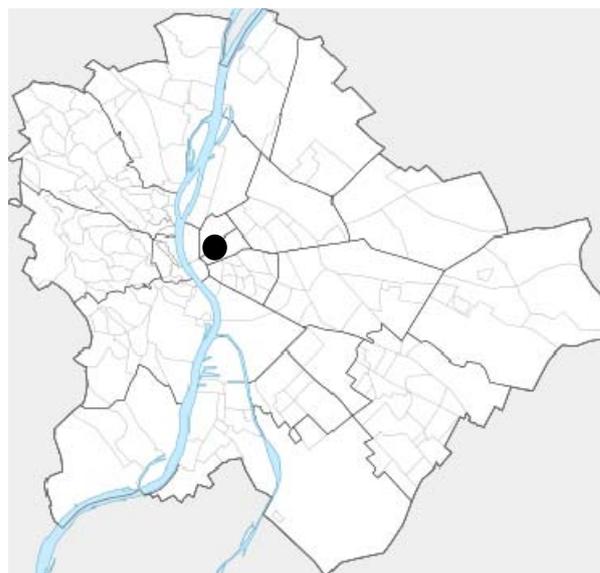
Fig. 1 The Old Jewish Quarter of Pest, in today's District 7 of Budapest [3]

The development started in the 18th century lasted nearly for a hundred years. The narrow, rectilinear streets, the organic

network, the frequent T-shaped intersections, as well as the diverse width of the streets can be originated from the agricultural past of the area. This kind of organic fabric can rarely be found in today's regulated Budapest [2].

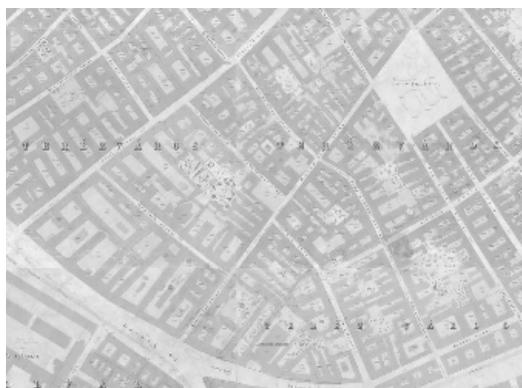
Fig. 2 Characteristic urban fabric of the turn of the 19th and 20th century in the district [4]

Until Joseph II, Emperor and King of Austro-Hungarian Empire, legislated the Patent of Toleration in 1783, Jews were prohibited to enter the walled Pest, and were also not allowed to settle until 1786. A law of 1840 at last permitted them to own real estate, until then, their praying rooms and apartments were also in rented houses. Naturally, the establishment started around the Jewish Market outside the city wall, alongside the main street of the area: Király Street (King Street, King of England Street at the time, Fig. 2) [2].

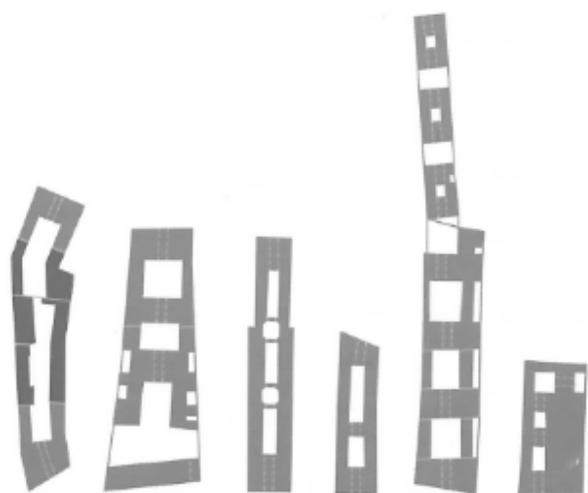
Fig. 3 Passage houses- chain layout connecting the streets and opening up the deep block for commercial life [2]

At the same time, the first passage houses (Fig. 3) and pedestrian crossings have developed through the deep blocks, later grown into a full system. The passage houses and crossings expanded the commercial life, at the same time

The vaguely regulated urban development resulted diverse blocks and irregular lots (Figs. 3, 4). The size and shape of the different lots as well as the changing architecture historical periods offers the rare sight of diverse tenement houses adjacent to each other [5].

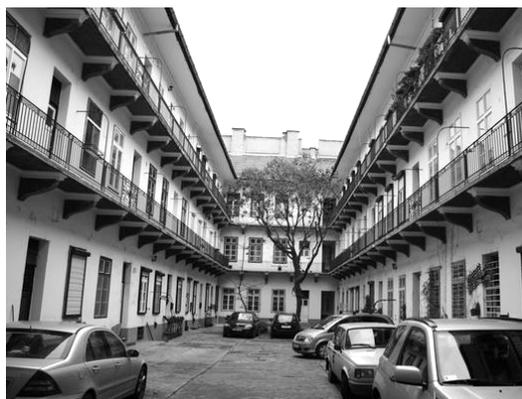
Fig. 7 Larger inner courtyard in the Jewish Quarter of Pest (Photo is courtesy of Kővári Csenge, Mészáros Mónika and Hegedűs Marcell – Ybl Miklós Faculty of Architecture)

In case of every architectural era, the enclosed geometry of the tenement houses with inner courtyard can be marked as characteristic. However, due to the higher ratio of early buildings, more L, U, or enclosed structure remained with spacious courtyard (Figs. 6, 7) – which is unique compared to the adjacent districts.

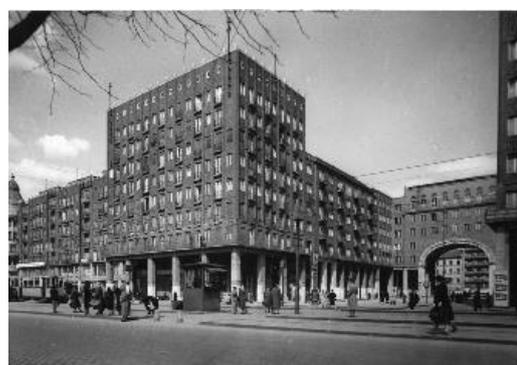
Fig. 8 Opening of Madách Boulevard the older buildings can still be seen through the gate motif [9]

The project of Madách Sugárút (Madách Boulevard) has been the most grandiose intervention in the mainly organic structure. The idea of the first so called Erzsébet (referring to Queen Elisabeth again) then later Madách Boulevard was first introduced in the beginning of the 20th century. The concept was to open a main road to rival the nearby Andrassy Boulevard, which is ever since its opening has been the most important avenue of the area. Several plans were created, from which in 1930’s, the complex of 11 interlocking buildings were built with a great gate motif to open up the densely built in inner parts. The plan however halted here, and only the beginning of the boulevard was built (Figs. 8, 9) [8].

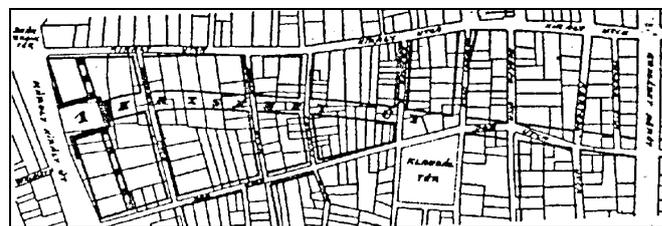
Fig. 9 Plan of Madách Boulevard – only the opening on the left part was finished [7]

Since the 1940’s, various plans had been created and many suggestions were made to finish the project. Some critics pointed out that the plan is disregarding the current structure of the city [8] – the plan would have demolished significant early buildings and monuments, and would have brought a different scale of road and building stock to the area.

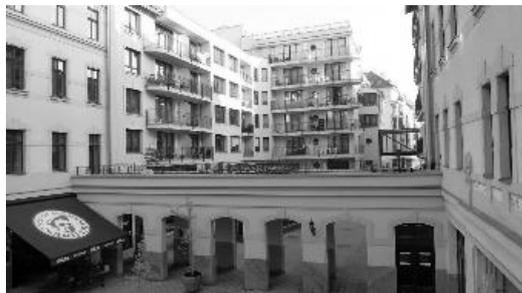
Fig.10 Contemporary buildings in the passage-section of the boulevard [10]

The Madách Promenade remained on topic ever since. The latest plans suggested the evolution of the boulevard to a promenade, then a passage [7], which is a more delicate intervention than its predecessors, reducing the Boulevard to a passage. The latest constructions have been created in this regard (Fig. 10). The investment undoubtedly increased the

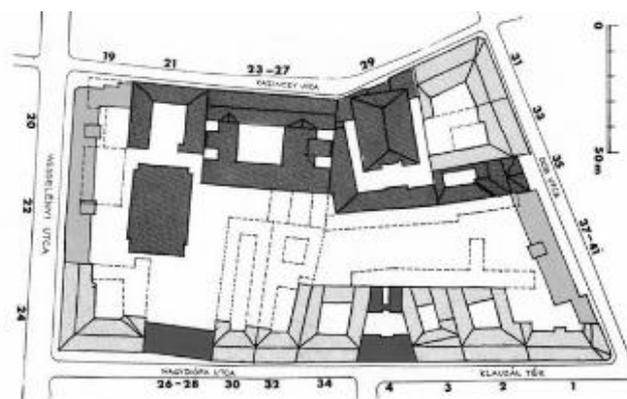
Fig. 11 Sample Block Nr. 15 after rehabilitation. The demolished wings are marked with dashed line [13]

The Erzsébetváros rehabilitation was started with the Sample Block Nr. 15 (Fig. 11).

The Sample Block Nr 15. contained a synagogue and other ecclesiastic buildings. Out of the existing 303 flats, 150 were

demolished, to build 170 in entirely new buildings. The average 49 m² floor space of the existing flats were enlarged averagely to 65 m². The inside of the blocks were rebuilt as parks and playgrounds. Between 1982 and 1985, the construction was finished. Above residential development, the public buildings (a university, a museum and offices) were renovated or given new buildings. Majority of the new residents were the same as before, or moved here from the adjacent blocks [11].

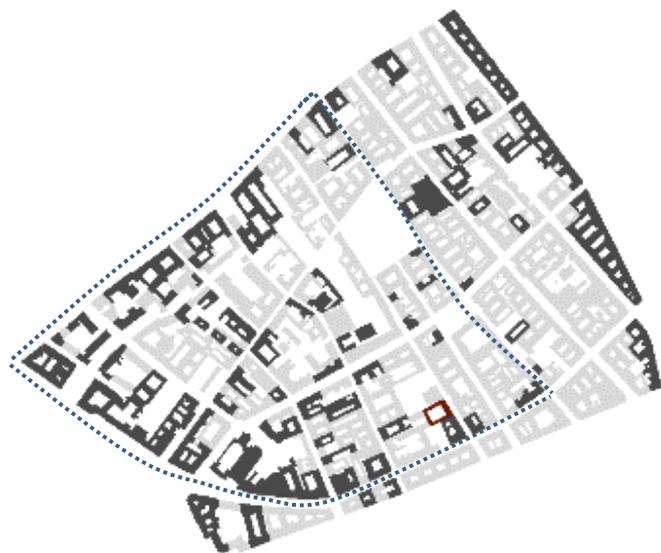
Fig. 12 Buildings under individual protection is shown with darker shade, the UNESCO buffer one area is marked by dotted line. It is also a conservation area. Based on [7]

As acknowledgement of its significance, it became part of the UNESCO World Heritage Area, which consist of the Buda Castle Hill, the Danube banks, the Andrásy Avenue (Fig. 12).
