Assessing the Sheltering Response in the Middle East: Studying Syrian Camps in Jordan

Abstract—This study focuses on the sheltering response in the Middle East, specifically through reviewing two Syrian refugee camps in Jordan, involving Zaatari and Azraq. Zaatari camp involved the rapid deployment of tents and shelters over a very short period of time and Azraq was purpose built and pre-planned over a longer period. At present, both camps collectively host more than 133,000 occupants. Field visits were taken to both camps and the main issues and problems in the sheltering response were highlighted through focus group discussions with camp occupants and inspection of shelter habitats. This provided both subjective and objective research data sources. While every case has its own significance and deployment to meet humanitarian needs, there are some common requirements irrespective of geographical region. The results suggest that there is a gap in the suitability of the required habitat needs and what has been provided. It is recommended that the global international response and support could be improved in relation to the habitat form, construction type, layout, function and crit

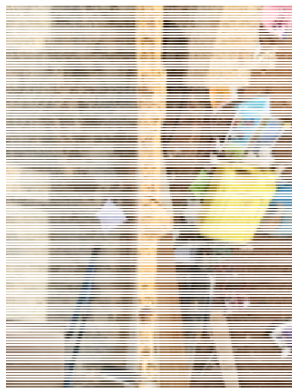
Fig. 4 A section in the wall [13]

- *Walls and roofs:* The prefabricated shelters were made from polyurethane insulated sandwich panels. A section of the wall can be seen in Fig. 4, which was recycled from a shelter's wall and used as a side garden fence. The shelters' quality differs from one to another, but the majority have weaknesses in building fabric leading to air,

dust and water ingress. This is a contributing source towards health problems affecting camp residents.

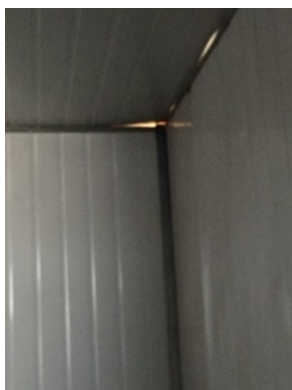
Fig. 5 Gaps between junctions [13]

In an attempt to seal the shelters, especially the roof-wall junctions (Fig. 5), the residents covered the roofs using fabrics they had or bought them, if they could afford them. Some families also tried to expand their shelters by enclosing a space using corrugated sheets and then covered it with fabric,

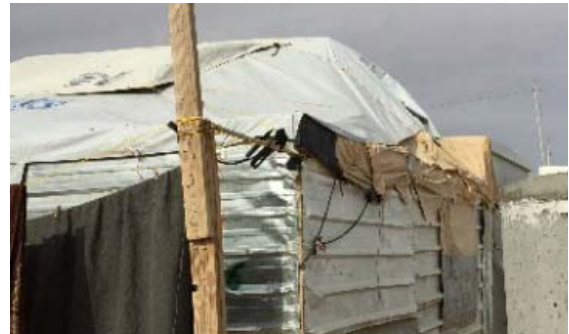
Fig. 6 Extended area example [13]

which is not a durable solution and cannot replace a proper roof (Fig. 6). The expanded area fulfilled some major needs such as providing separated sleeping areas for different genders and ages within the family, or providing a separate area for socializing and receiving guests. Social interaction can be an important aspect to communities in general. This is perhaps more critical for refugees to assist interaction and alleviate the trauma of leaving their home and country.

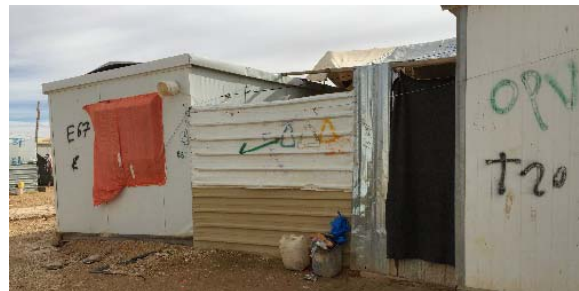
Fig. 7 A covered window to protect the privacy [13]

ventilation function of the shelters. Residents covered their windows from the outside or from the inside (Fig. 7) due to passers-by being able to look into the shelter. Residents stated that having privacy was a necessity and a priority and aligned strongly with cultural and religious beliefs.

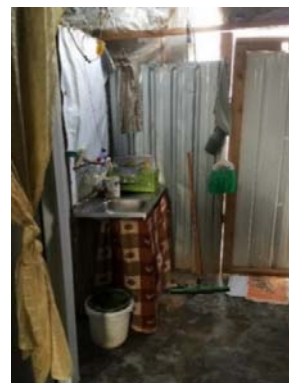
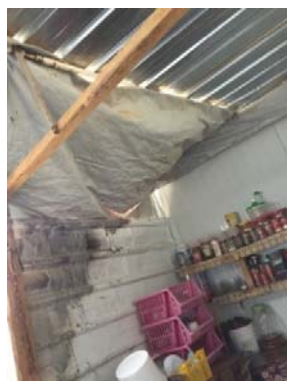
Fig. 8 Self-built kitchen [13]

- **Facilities:** When the camp was first opened, the kitchens and toilets provided were communal. Problems occurred when using such communal facilities from both cultural and privacy/security perspectives. It was found that when residents could afford some materials, they adapted and self-built private facilities adjacent to their shelters. These adaptations included enclosing additional space with corrugated sheets, wood and canvas, if the residents were able to afford materials (Figs. 8 and 9).
- **Outdoor areas:** The courtyard is an important cultural feature in Syrian homes and enclosing an outdoor space

Fig. 9 Self-built kitchen [13]

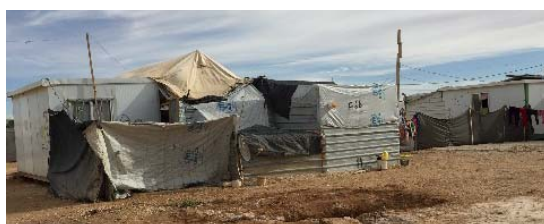
Fig. 10 Private outdoor area [13]

was found to be very important to the camp residents. They often enclosed a space next to their shelter or between two shelters with canvas or corrugated sheets, as shown in Fig. 10. One of the main benefits of such a private area was for women residents to have access to an outside space. This provided safety, privacy and aligned to their cultural needs.

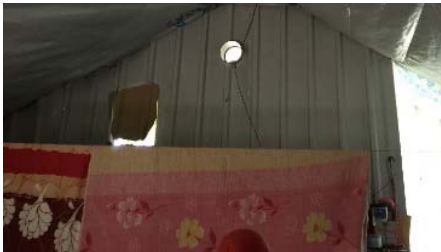
Fig. 15 Blanket dividers [15]

The shelter is a basic design involving a one-room plan. The original design had indicated ‘partitioning wires’ to support fabric room dividers, but were never installed. Residents believe that it is not acceptable culturally nor religiously to have different ages and genders sleeping in the same room. They erected their own fabric dividers using their own sheets or blankets as and when required (Fig. 15).

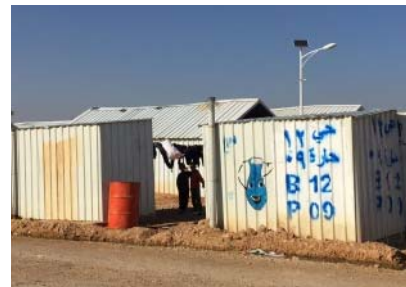
Fig. 19 Communal unit for toilet and shower [15]

- **Facilities:** Toilets are communal in Azraq camp and each unit (toilet and a shower) is used by approximately three families (Fig. 19). Residents had ceased to use the communal showers due to safety concerns and opted to shower in their own shelters using buckets of water. The shelters were not designed to have internal showers nor is their space provision. The main difficulties regarding using communal facilities are:

- hygiene problems: used by large numbers,
- distance problem: using the toilets in winter is problematic, especially for children, due to the distance and the harsh weather,
- ground turns into mud after raining, and
- lack of security and safety: specifically, for children and women at night.

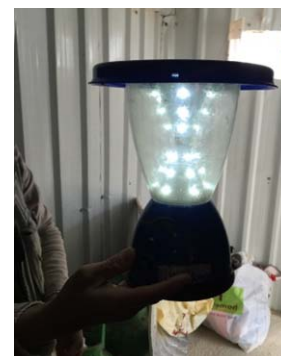
Fig. 25 Solar lamp [15]

The only source for electricity in the Azraq camp is solar lamps (Fig. 25). Shelters have one or two lamps but no additional devices, other than mobile phones, can be operated by these lamps.
