Assessing the Sheltering Response in the Middle East: Studying Syrian Camps in Jordan

Lara A. Alshawawreh, R. Sean Smith, John B. Wood

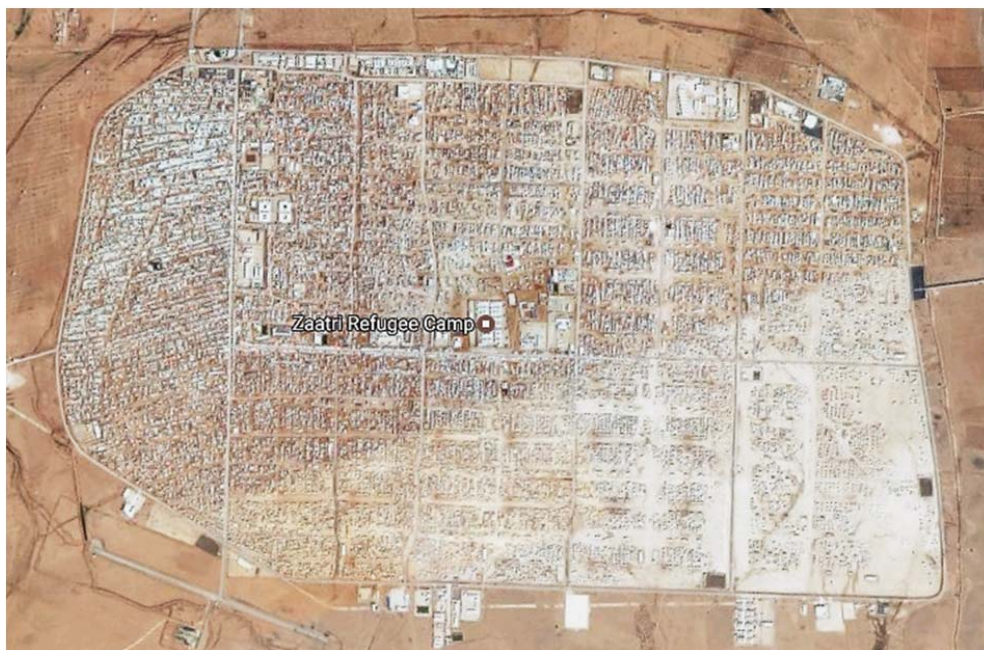
Fig. 1 Zaatari camp general map [10]

Zaatari camp has an area of 5.3km² [7], hosting 79,737 refugees [4]. It is divided into 12 districts, each district breaks up into numbered parcels of land with defined borders called 'blocks', and each block has many shelters (Fig. 1). Azraq has an area of 14.7km² [8] hosting 53,833 refugees [9]. The camp is divided into villages, blocks, streets, and numbered shelters. Only villages numbered three and six were opened and used when the study was taken. The outline of the camp is shown in Fig. 2.

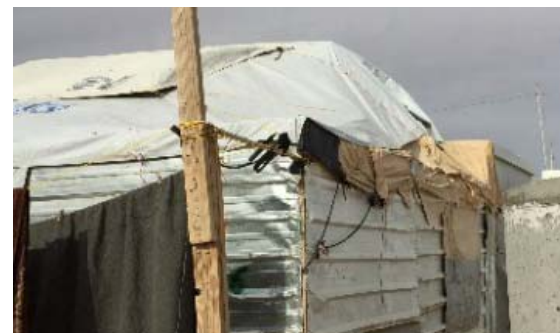
Fig. 6 Extended area example [13]

In an attempt to seal the shelters, especially the roof-wall junctions (Fig. 5), the residents covered the roofs using fabrics they had or bought them, if they could afford them. Some families also tried to expand their shelters by enclosing a space using corrugated sheets and then covered it with fabric,

which is not a durable solution and cannot replace a proper roof (Fig. 6). The expanded area fulfilled some major needs such as providing separated sleeping areas for different genders and ages within the family, or providing a separate area for socializing and receiving guests. Social interaction can be an important aspect to communities in general. This is perhaps more critical for refugees to assist interaction and alleviate the trauma of leaving their home and country.

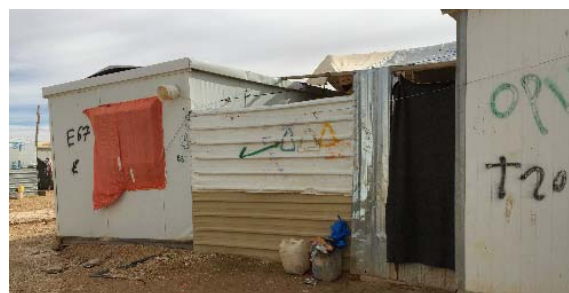
Fig. 7 A covered window to protect the privacy [13]

- **Floors:** The original shelter floor was made from wood. This is an unfamiliar floor material to the residents. In addition, the floors were damp and caused a musty smell due to water ingress. The floor materials and cavities beneath were easily accessible by rats. This led the residents to replace the wooden floor with concrete.
- **Windows:** It was found that amendments made by residents to improve privacy was also affecting the

ventilation function of the shelters. Residents covered their windows from the outside or from the inside (Fig. 7) due to passers-by being able to look into the shelter. Residents stated that having privacy was a necessity and a priority and aligned strongly with cultural and religious beliefs.

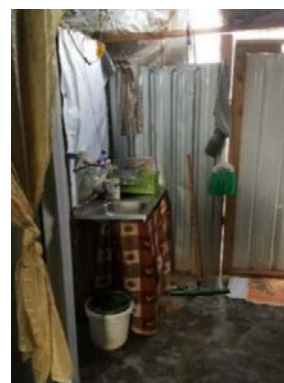
Fig. 8 Self-built kitchen [13]

- **Facilities:** When the camp was first opened, the kitchens and toilets provided were communal. Problems occurred when using such communal facilities from both cultural and privacy/security perspectives. It was found that when residents could afford some materials, they adapted and self-built private facilities adjacent to their shelters. These adaptations private facilities included enclosing additional space with corrugated sheets, wood and canvas, if the residents were able to afford materials (Figs. 8 and 9).
- **Outdoor areas:** The courtyard is an important cultural feature in Syrian homes and enclosing an outdoor space

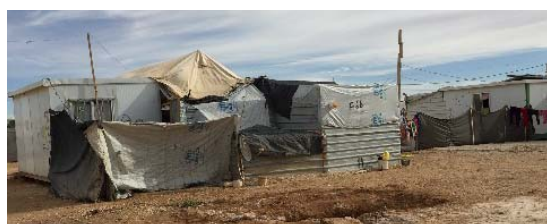
Fig. 10 Private outdoor area [13]

was found to be very important to the camp residents. They often enclosed a space next to their shelter or between two shelters with canvas or corrugated sheets, as shown in Fig. 10. One of the main benefits of such a private area was for women residents to have access to an outside space. This provided safety, privacy and aligned to their cultural needs.

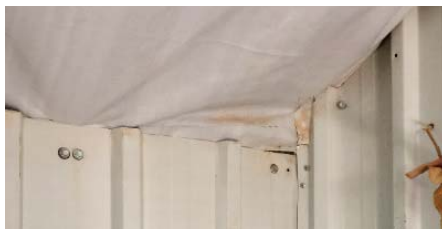
Fig. 14 Sharp edges in cladding [15]

- **Walls and roofs:** The junctions between the walls and the roof are not well-sealed and were found to leak water and dust. Residents mentioned they preferred a flat roof rather than a pitched roof, as they thought this would be easier to seal and it was more familiar to them. Due to the camp's strict policies regarding making any changes to the shelters, residents could not change the roof. The wall heights were low; however, the pitched roof design did provide more head-room. The overlapping of the internal metal cladding sheets resulted in sharp edges, as shown in Fig. 14, and residents had stated that injuries had occurred.

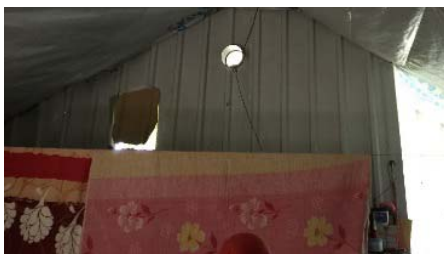
Fig. 15 Blanket dividers [15]

The shelter is a basic design involving a one-room plan. The original design had indicated ‘partitioning wires’ to support fabric room dividers, but were never installed. Residents believe that it is not acceptable culturally nor religiously to have different ages and genders sleeping in the same room. They erected their own fabric dividers using their own sheets or blankets as and when required (Fig. 15).

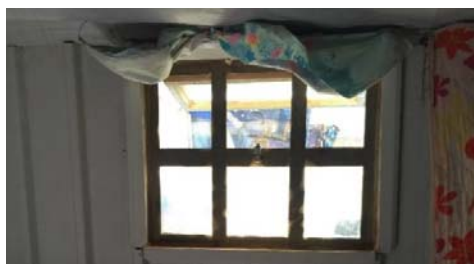
Fig. 16 The T-shelter window [15]

- **Windows:** Shelters in Azraq camp have only one small window (Fig. 16). The problem is increased as residents close their windows and shade them using fabrics because they directly overlook public areas or other residents’ windows and do not provide adequate privacy.

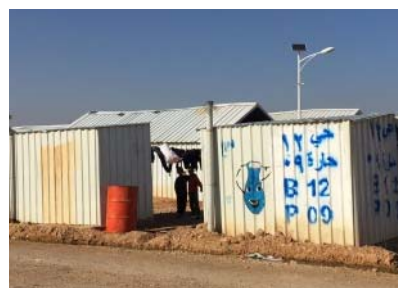
Fig. 19 Communal unit for toilet and shower [15]

- **Facilities:** Toilets are communal in Azraq camp and each unit (toilet and a shower) is used by approximately three families (Fig. 19). Residents had ceased to use the communal showers due to safety concerns and opted to shower in their own shelters using buckets of water. The shelters were not designed to have internal showers nor is their space provision. The main difficulties regarding using communal facilities are:

- hygiene problems: used by large numbers,
- distance problem: using the toilets in winter is problematic, especially for children, due to the distance and the harsh weather,
- ground turns into mud after raining, and
- lack of security and safety: specifically, for children and women at night.
