Assessing the Sheltering Response in the Middle East: Studying Syrian Camps in Jordan

Lara A. Alshawawreh, R. Sean Smith, John B. Wood

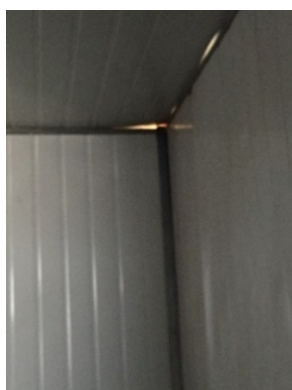
In an attempt to seal the shelters, especially the roof-wall junctions (Fig. 5), the residents covered the roofs using fabrics they had or bought them, if they could afford them. Some families also tried to expand their shelters by enclosing a space using corrugated sheets and then covered it with fabric,

Fig. 5 Gaps between junctions [13]

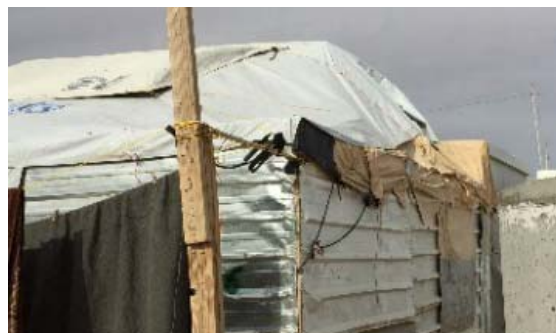
which is not a durable solution and cannot replace a proper roof (Fig. 6). The expanded area fulfilled some major needs such as providing separated sleeping areas for different genders and ages within the family, or providing a separate area for socializing and receiving guests. Social interaction can be an important aspect to communities in general. This is perhaps more critical for refugees to assist interaction and alleviate the trauma of leaving their home and country.

Fig. 6 Extended area example [13]

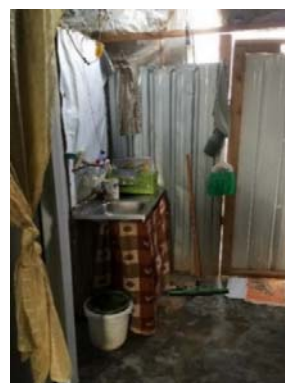
Fig. 8 Self-built kitchen [13]

- **Facilities:** When the camp was first opened, the kitchens and toilets provided were communal. Problems occurred when using such communal facilities from both cultural and privacy/security perspectives. It was found that when residents could afford some materials, they adapted and self-built private facilities adjacent to their shelters. These adaptations private facilities included enclosing additional space with corrugated sheets, wood and canvas, if the residents were able to afford materials (Figs. 8 and 9).
- **Outdoor areas:** The courtyard is an important cultural feature in Syrian homes and enclosing an outdoor space

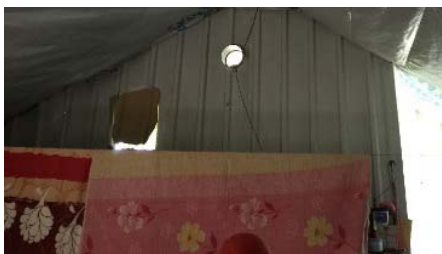
Fig. 15 Blanket dividers [15]

The shelter is a basic design involving a one-room plan. The original design had indicated ‘partitioning wires’ to support fabric room dividers, but were never installed. Residents believe that it is not acceptable culturally nor religiously to have different ages and genders sleeping in the same room. They erected their own fabric dividers using their own sheets or blankets as and when required (Fig. 15).

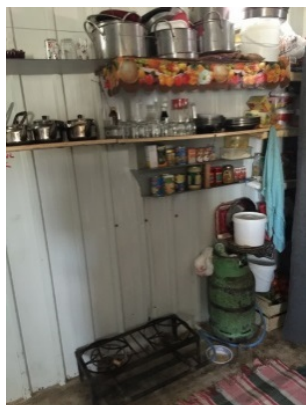
The residents were not provided with private or communal kitchens. Cooking equipment was given to residents to utilize in a corner of their shelters as a kitchen space. This included stoves and gas cylinders as shown in Fig. 20. Cooking inside the shelters was one of the causes behind the respiratory problems the residents had mentioned.

Fig. 20 Kitchen tools [15]

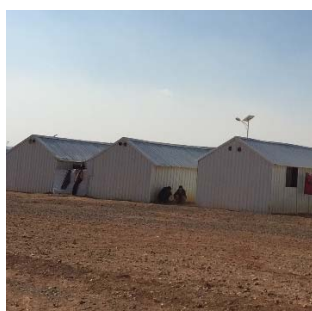
and an absence of private social spaces whether outside or inside. Fig. 21 illustrates residents sitting in the shade close to the edge of an external wall. This shows the importance of this external space for socializing. The residents tried to overcome the problem by removing the inner lining of the shelter roof (plastic sheeting) to use as an exterior partition to form a private outdoor space (Fig. 22).

Fig. 21 Original gap between shelters [15]

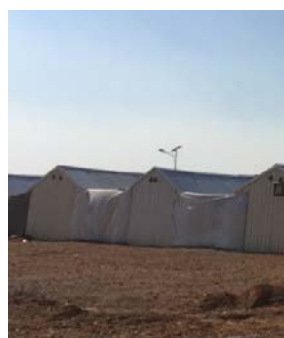
Fig. 22 Enclosed outdoor area [15]

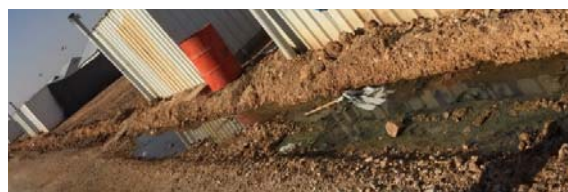
- *Drainage:* The absence of a drainage system is a problem in the Azraq camp. The residents formed ditches to outside pits and aligned different ditches to form a network of surface wastewater channels adjacent to the streets, as shown in Fig. 23. In addition to hygiene problems, it also leads to accessibility issues for people with special needs and elderly, trying to cross over the wastewater.

Fig. 23 Surface runoff wastewater [15]

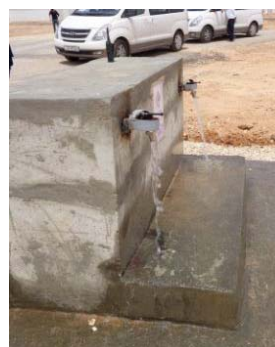
- *Water and electricity:* Water taps are distributed around the camp, as shown in Fig. 24, and are piped from the primary main water tanks located on the camp edge. There is approximately one tap for every three blocks and operates from 7 a.m. – 12 p.m. and from 7 p.m.-12 a.m. Residents fill up bottles or containers (if they have enough) for their daily usage. There is no limit for the amount of water they can take, but there is long distance to reach the closest tap. Children are the primary water carriers, which can be up to 20 liters per day according to the residents.

Fig. 24 A water tap [15]

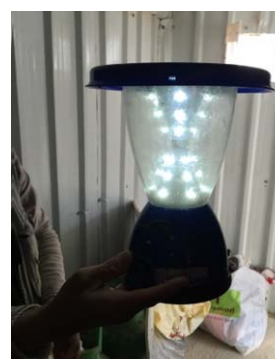
The only source for electricity in the Azraq camp is solar lamps (Fig. 25). Shelters have one or two lamps but no additional devices, other than mobile phones, can be operated by these lamps.

Fig. 25 Solar lamp [15]
