Triplet Shear Tests on Retrofitted Brickwork Masonry Walls

Berna Istegun, Erkan Celebi

Abstract—The main objective of this experimental study is to assess the shear strength and the crack behavior of the triplets built of perforated brickwork masonry elements. In order to observe the influence of shear resistance and energy dissipating before and after retrofitting applications by using the reinforcing system, static-cyclic shear tests were employed in the structural mechanics laboratory of Sakarya University. The reinforcing system is composed of hybrid multiaxial seismic fabric consisting of alkali resistant glass and polypropylene fibers. The plaster as bonding material used in the specimen's retrofitting consists of expanded glass granular. In order to acquire exact measuring data about the failure behavior of the two mortar joints under shear stressing, vertical load-controlled cylinder having force capacity of 50 kN and loading rate of 1.5 mm/min. with an internal inductive displacement transducers is carried out perpendicular to the triplet specimens. In this study, a total of six triplet specimens with textile reinforcement were prepared for these shear bond tests. The th

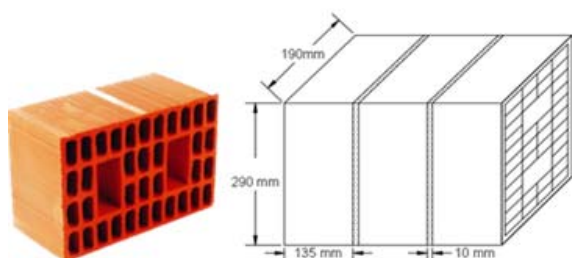
Fig. 1 Brick block and triplet specimen

Technical features of perforated bricks are given in the Table I. Each produced test set consists of a triplet of perforated brick blocks with three identical specimens (Fig. 1). Moreover, there are three sets of triplet specimens of which two of them were strengthened by using seismic fabric and its special plaster. The remaining one set of non-strengthening

Property	Unit	Value
Dimension	cm	19*29*13.5
Consumption	pcs/m ²	22-35
Gross Dry Unit Vol. Mass	kg/m ³	700
Net Dry Unit Vol. Mass	kg/m ³	1800
Pressure Strength	N/mm ²	10
Thermal Conductivity Factor	W/mK	0.32
Fire Resistance	-	A1
Tolerance Category	-	T1

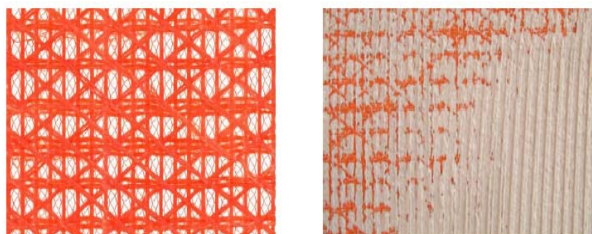
Fig. 2 The hybrid multiaxial seismic textile

The plaster and seismic fabric are implemented in two forms: Unilateral (D1G03) and bilateral (D1G04-T). Additionally, the thickness of plaster layer is equal to 2 cm for D1G03 and 1 cm (on each surface) for D1G04-T. The strengthening process is a combination of multi-axis hybrid seismic textile and special adhesive plaster (Fig. 2). This textile material comprises of alkali-resistant glass and polypropylene fibers.

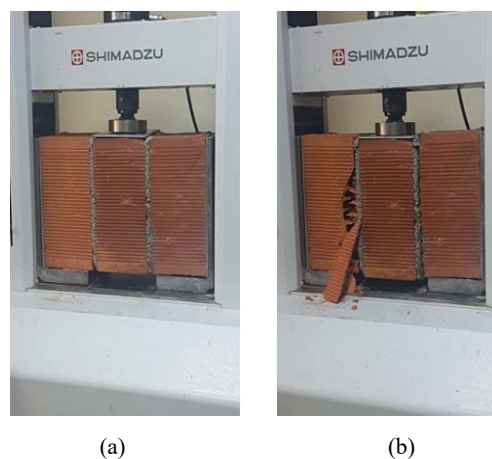
Fig. 4 (a) Initial state and (b) final state of D1R00-1

Firstly, the shear capacity was investigated without applying any plaster which was defined as the reference sample of the non-retrofitted masonry specimen. To describe this case, the non-strengthened control specimens are called as D1R00. Due to the fact that there are three specimens for each experiment set, each sample in the set is designated as D1R00-1, D1R00-2, and D1R00-3, respectively. Both initial and final states of failure under triplet shear test for D1R00-1 are given in Fig. 4.

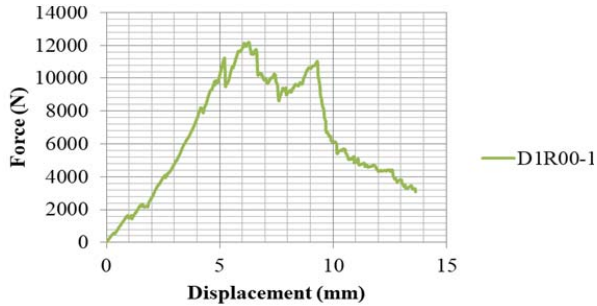
Fig. 5 Force-displacement diagram of the D1R00-1

The maximum shear force F_{max} for this sample is obtained as 12200 N. The attained force-displacement relationship is illustrated in Fig. 5.

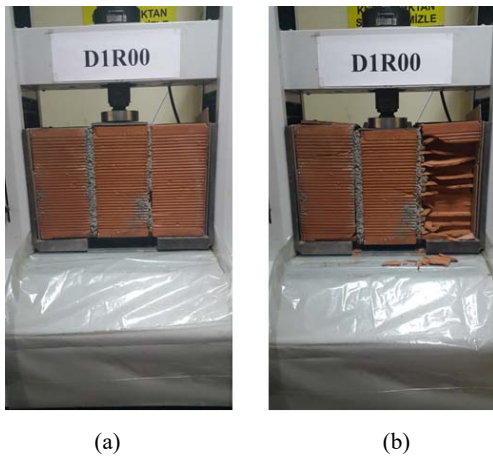
Fig. 6 (a) Initial state and (b) final state of D1R00-2

Similarly, triplet shear tests were performed for the D1R00-2 and D1R00-3 and the resulting crack forms are shown in Figs. 6 and 8, respectively.

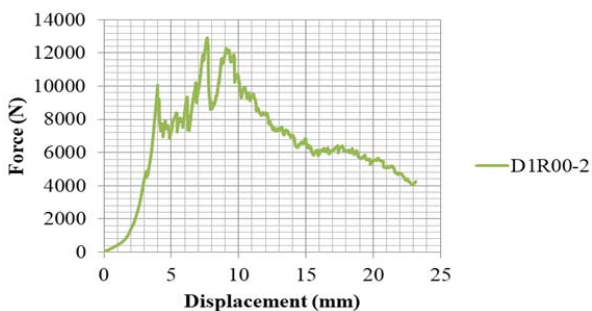
Fig. 7 Force-displacement diagram of the D1R00-2

As can be seen from Figs. 7 and 9, due to lack of ductility, the shear strength of the brick units suddenly decreased and brittle fractures occurred rapidly under stress. These damages are abrupt. The failure surface of specimen exhibits little degradation before the fracture occurs.

In this case, the shear strength, f_v are calculated as 0.117 MPa and 0.138 MPa by considering the experimentally

obtained maximum force of 12920 N and 15316 N, respectively.

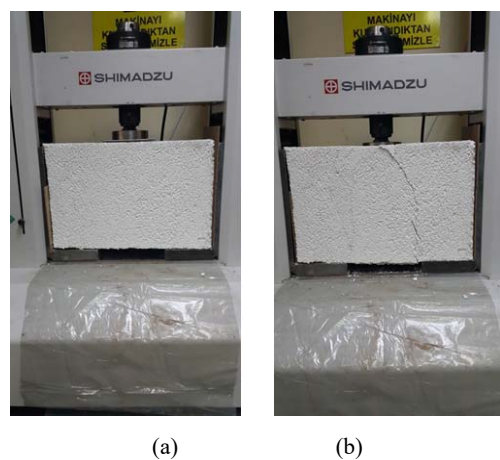
Fig. 10 (a) Initial state and (b) final state of D1G03-1

In the second stage of the experimental study, the effect of the applied seismic textile and the plaster made of expanded glass granular on the shear capacity of mortar joints was investigated. Hereby, the one-sided retrofitted brick specimen with 20 mm reinforcing layer is named as D1G03 for triplet shear test. Firstly, D1G03-1 was tested. The crack pattern of this specimen can be seen in Fig. 10.

The first cracks on the specimens under shear forces were

experienced in vertical form and occurred in brick-mortar interface. When the imposed load reached close to the shear strength capacity of the specimen, the crack widths increased and the middle block separated from the joint plane.

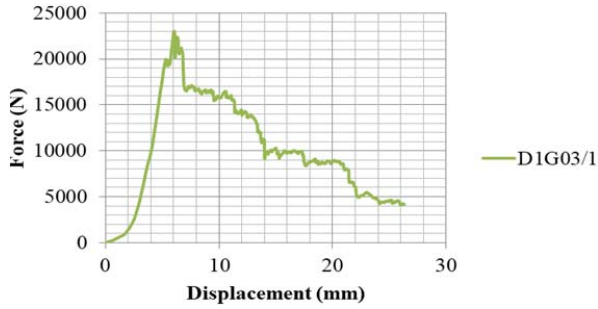
Fig. 11 Force-displacement diagram of the D1G03-1

As shown in Fig. 11, the maximum shear force F_{max} is obtained as 23033 N and the corresponding shear stress value f_v is calculated as 0.209 MPa for specimen of D1G03-1.

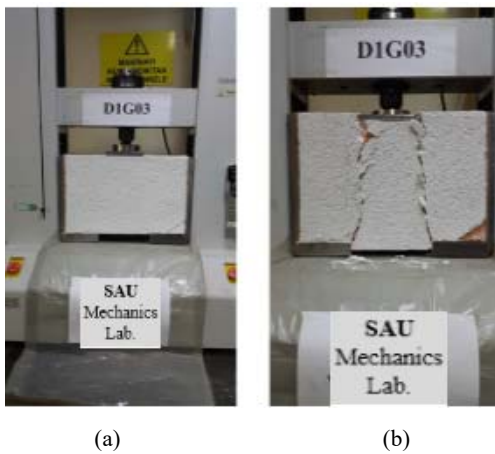
Fig. 12 (a) Initial state and (b) final state of D1G03-2

For the D1G03-2 and D1G03-3 specimens; crack patterns, maximum shear loads and strength parameters were similarly determined. The failure mechanism of the test specimens under the vertical load is shown in Figs. 12 and 14. The maximum shear forces of the second and third sample of the D1G03 test set are equal to 24548 N and 29427 N, respectively (Figs. 13 and 15).

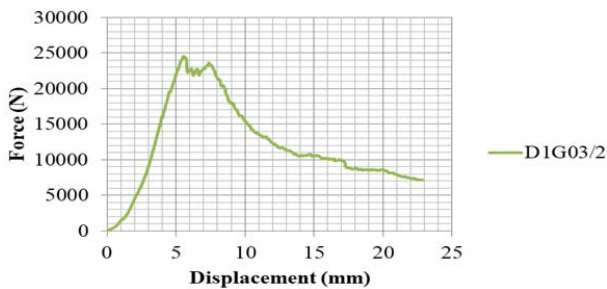
Fig. 13 Force-displacement diagram of the D1G03-2

The values of f_v are 0.220 MPa and 0.267 MPa for D1G03-2

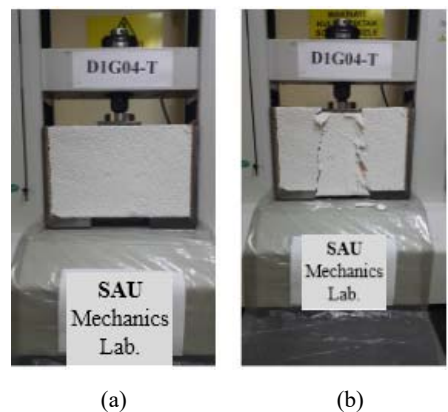
Fig. 16 (a) Initial state and (b) final state of D1G04-T/1

In the final phase of the study, the above mentioned strengthening system was applied to both surfaces of the three specimens and the results were analyzed comparatively. The thickness of the plaster on each surface was considered as 1 cm. The experiment set was named as D1G04-T. Initial and final states of D1G04-T/1 under shear force were in Fig. 16.

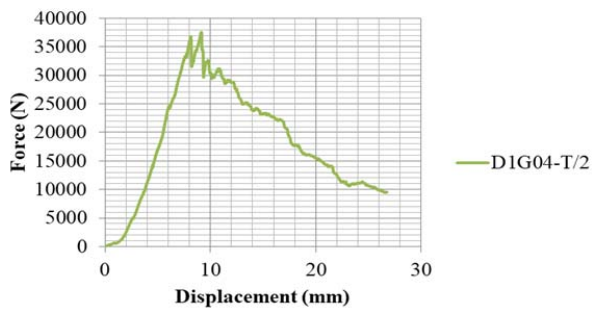
Fig. 19 Force-displacement diagram of the D1G04-T/2

The F_{max} values were determined for these specimens as 37544 N and 36394 N, respectively. The shear strengths were calculated as 0.340 MPa and 0.330 MPa, respectively. The experimental shear force-displacement curve for D1G04-T/2 and D1G04-T/3 are illustrated in Figs. 19 and 21.

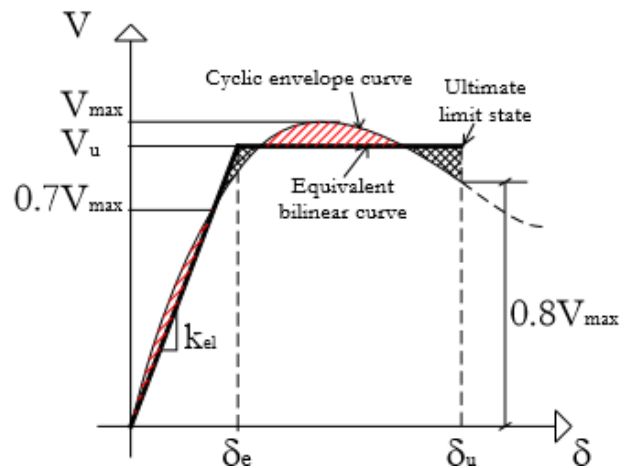
Fig. 22 Bilinear Idealization

Magenes and Morandi [11] calculated the ductility coefficients by idealizing the envelope curve obtained from the experiment with equivalent bilinear curves (Fig. 22). In a similar way, the energy-dissipation capacities of the samples were determined (3), with the force-displacement curves being idealized in this research.

$$\mu = \frac{\delta_u}{\delta_e} \quad (3)$$

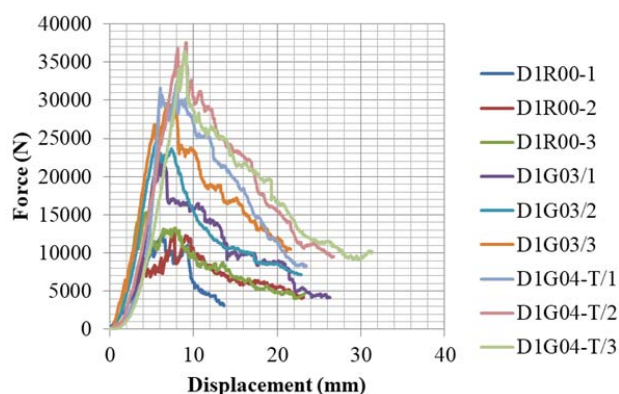
Fig. 23 Comparison of force-displacement diagrams

It is easy to see from the obtained ductility coefficients in Table III, D1G04-T coded samples exhibit a more ductile behavior compared to the other set of experiments (D1G03) and reference samples are insufficient in terms of load bearing capacity, shear strength and energy dissipation. The results of all triplet shear tests performed were compared in Fig. 23.

The obtained results of the experimental investigations are given with respect to force-displacement curves comparatively for all considered test specimens. It is concluded that the single-sided reinforcing application provided enhancement in shear resistance of 68% and improvement in deformability

capacity of 19%. However, two-sided reinforcing provided remarkable additional strength up to 168% and increase in ductility of 46%.
