Triplet Shear Tests on Retrofitted Brickwork Masonry Walls

Berna Istegun, Erkan Celebi

Abstract—The main objective of this experimental study is to assess the shear strength and the crack behavior of the triplets built of perforated brickwork masonry elements. In order to observe the influence of shear resistance and energy dissipating before and after retrofitting applications by using the reinforcing system, static-cyclic shear tests were employed in the structural mechanics laboratory of Sakarya University. The reinforcing system is composed of hybrid multiaxial seismic fabric consisting of alkali resistant glass and polypropylene fibers. The plaster as bonding material used in the specimen's retrofitting consists of expanded glass granular. In order to acquire exact measuring data about the failure behavior of the two mortar joints under shear stressing, vertical load-controlled cylinder having force capacity of 50 kN and loading rate of 1.5 mm/min. with an internal inductive displacement transducers is carried out perpendicular to the triplet specimens. In this study, a total of six triplet specimens with textile reinforcement were prepared for these shear bond tests. The th

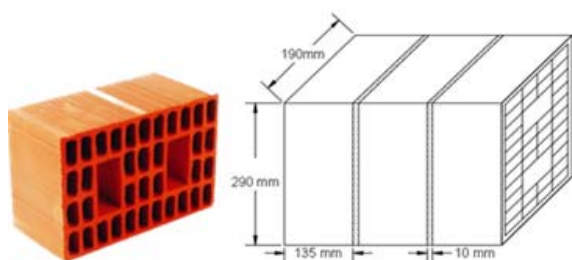
Fig. 1 Brick block and triplet specimen

Technical features of perforated bricks are given in the Table I. Each produced test set consists of a triplet of perforated brick blocks with three identical specimens (Fig. 1). Moreover, there are three sets of triplet specimens of which two of them were strengthened by using seismic fabric and its special plaster. The remaining one set of non-strengthening

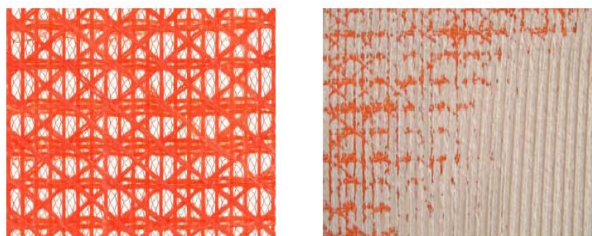
Fig. 2 The hybrid multiaxial seismic textile

The plaster and seismic fabric are implemented in two forms: Unilateral (D1G03) and bilateral (D1G04-T). Additionally, the thickness of plaster layer is equal to 2 cm for D1G03 and 1 cm (on each surface) for D1G04-T. The strengthening process is a combination of multi-axis hybrid seismic textile and special adhesive plaster (Fig. 2). This textile material comprises of alkali-resistant glass and polypropylene fibers.

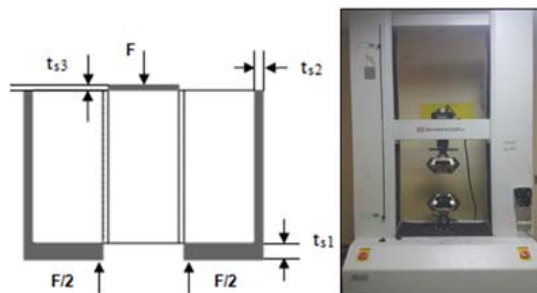
Fig. 3 Scheme of triplet shear test and test device

In this study, all experimental tests were executed at the structural mechanics laboratory of Sakarya University. A vertical load-controlled cylinder having force capacity of 50 kN and loading rate of 1.5 mm/min. was applied perpendicularly to the triplet specimens to investigate the failure behavior of the two mortar joints under shear stress. Triplet shear tests were conducted on perforated brick blocks with and without seismic retrofitting.

A steel plate with a thickness of 12 mm was situated on the middle brick of the triplet specimen in order to reduce the influence of the bending moment and transmit the load properly to the mortar. For providing the stability of the test setup, the outer two bricks were also supported by two steel L profiles. The results of the experimental study are recorded by a displacement sensor integrated into the load cylinder.

Test device in which all experiments conducted and the scheme of triplet test are illustrated in Fig. 3. The relevant thickness parameters (t_s) used in the triplet shear test are $t_{s1}=30$ mm, $t_{s2}=12$ mm and $t_{s3}=12$ mm, respectively.

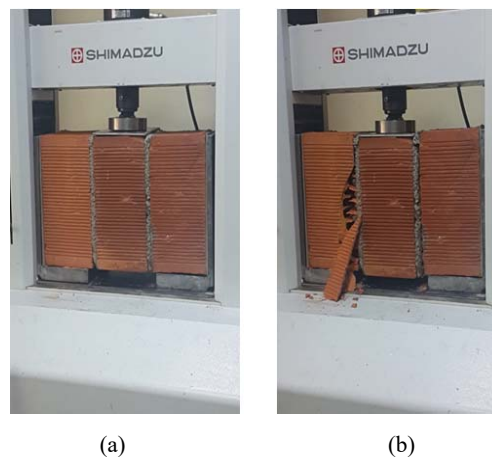
Fig. 4 (a) Initial state and (b) final state of D1R00-1

Firstly, the shear capacity was investigated without applying any plaster which was defined as the reference sample of the non-retrofitted masonry specimen. To describe this case, the non-strengthened control specimens are called as D1R00. Due to the fact that there are three specimens for each experiment set, each sample in the set is designated as D1R00-1, D1R00-2, and D1R00-3, respectively. Both initial and final states of failure under triplet shear test for D1R00-1 are given in Fig. 4.

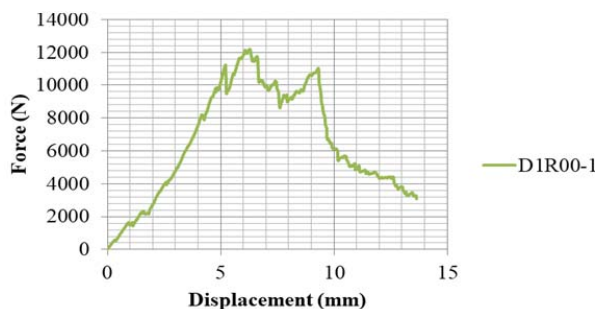
Fig. 5 Force-displacement diagram of the D1R00-1

The maximum shear force F_{max} for this sample is obtained as 12200 N. The attained force-displacement relationship is illustrated in Fig. 5.

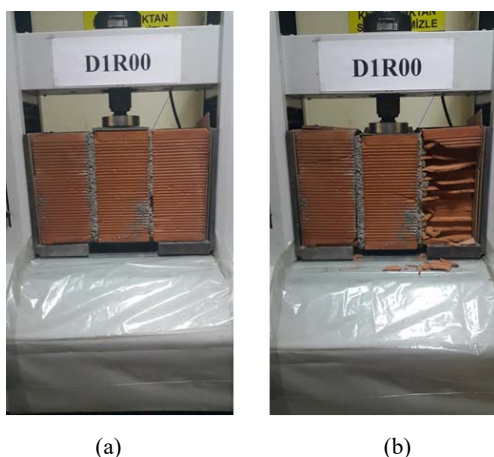
Fig. 6 (a) Initial state and (b) final state of D1R00-2

Similarly, triplet shear tests were performed for the D1R00-2 and D1R00-3 and the resulting crack forms are shown in Figs. 6 and 8, respectively.

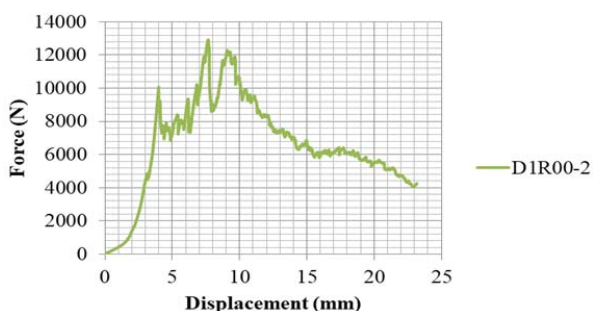
Fig. 7 Force-displacement diagram of the D1R00-2

As can be seen from Figs. 7 and 9, due to lack of ductility, the shear strength of the brick units suddenly decreased and brittle fractures occurred rapidly under stress. These damages are abrupt. The failure surface of specimen exhibits little degradation before the fracture occurs.

In this case, the shear strength, f_v are calculated as 0.117 MPa and 0.138 MPa by considering the experimentally

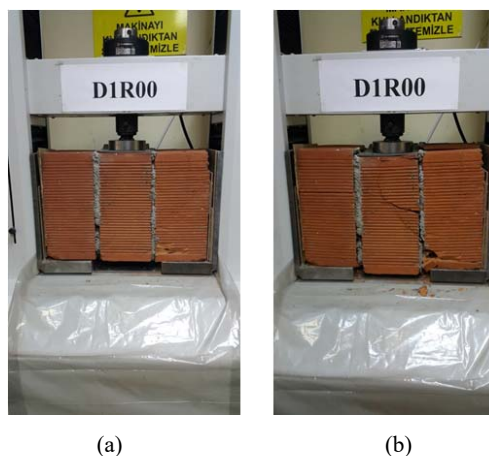
Fig. 8 (a) Initial state and (b) final state of D1R00-3

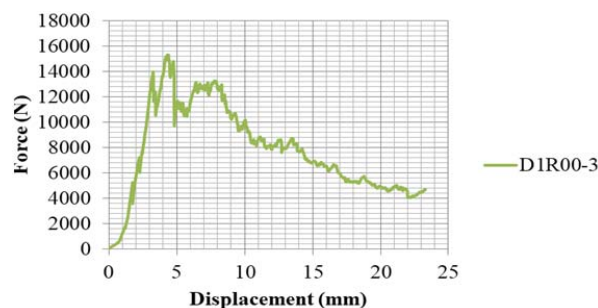
Fig. 9 Force-displacement diagram of the D1R00-3

obtained maximum force of 12920 N and 15316 N, respectively.

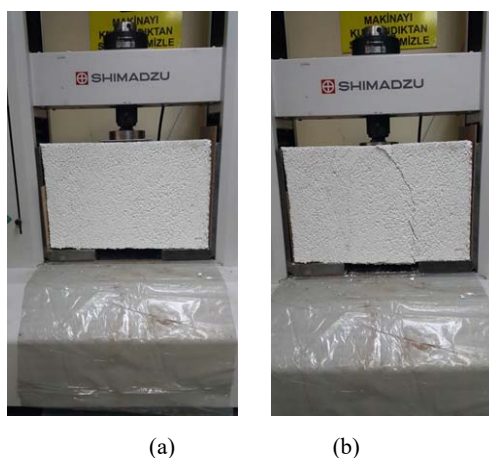
Fig. 10 (a) Initial state and (b) final state of D1G03-1

In the second stage of the experimental study, the effect of the applied seismic textile and the plaster made of expanded glass granular on the shear capacity of mortar joints was investigated. Hereby, the one-sided retrofitted brick specimen with 20 mm reinforcing layer is named as D1G03 for triplet shear test. Firstly, D1G03-1 was tested. The crack pattern of this specimen can be seen in Fig. 10.

The first cracks on the specimens under shear forces were

experienced in vertical form and occurred in brick-mortar interface. When the imposed load reached close to the shear strength capacity of the specimen, the crack widths increased and the middle block separated from the joint plane.

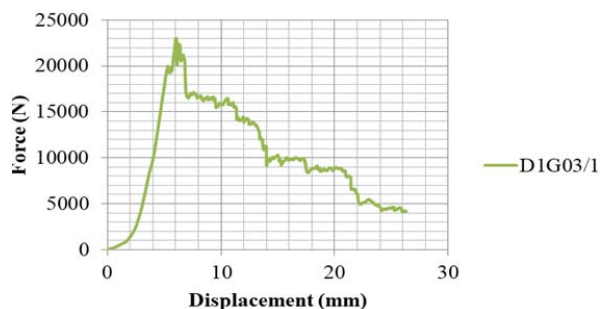
Fig. 11 Force-displacement diagram of the D1G03-1

As shown in Fig. 11, the maximum shear force F_{max} is obtained as 23033 N and the corresponding shear stress value f_v is calculated as 0.209 MPa for specimen of D1G03-1.

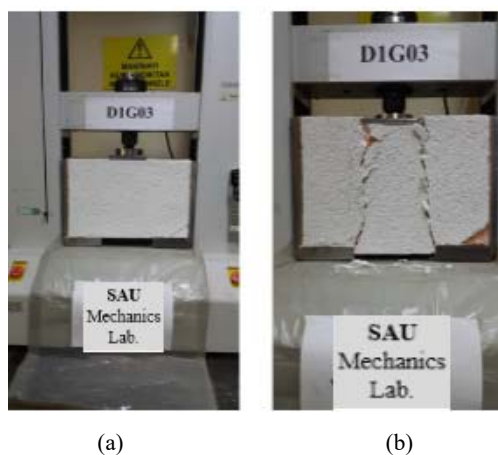
Fig. 12 (a) Initial state and (b) final state of D1G03-2

For the D1G03-2 and D1G03-3 specimens; crack patterns, maximum shear loads and strength parameters were similarly determined. The failure mechanism of the test specimens under the vertical load is shown in Figs. 12 and 14. The maximum shear forces of the second and third sample of the D1G03 test set are equal to 24548 N and 29427 N, respectively (Figs. 13 and 15).

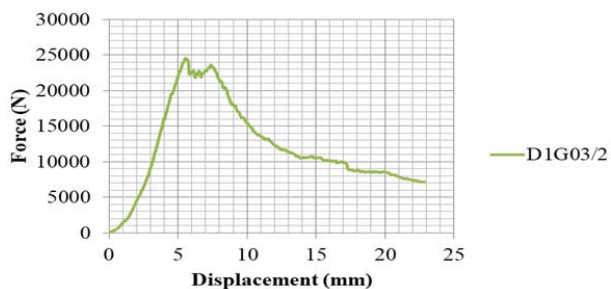
Fig. 13 Force-displacement diagram of the D1G03-2

The values of f_v are 0.220 MPa and 0.267 MPa for D1G03-2

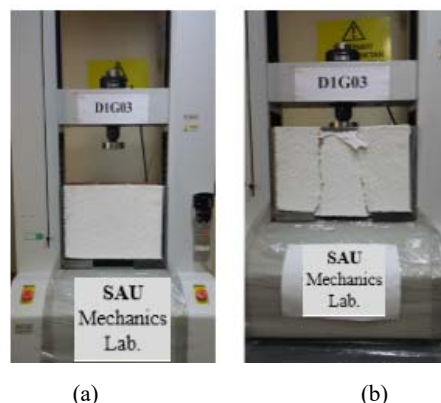
Fig. 14 (a) Initial state and (b) final state of D1G03-3

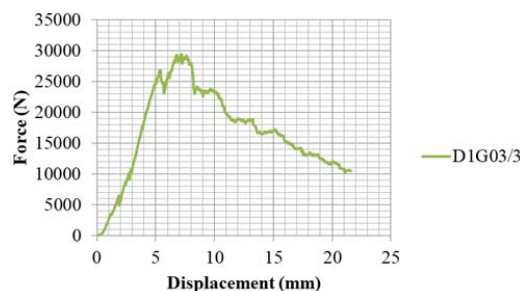
Fig. 15 Force-displacement diagram of the D1G03-3

and D1G03-3, respectively. Single-sided retrofitted triplets exhibited more ductile behavior when compared to the reference samples. Furthermore, it was clearly observed that the unilateral strengthening application significantly increased the shear capacity of the masonry building units. The measured value of F_{max} is 32611 N for this case. Also, f_v is calculated as 0.296 MPa. The curve of force-displacement relationship for D1G04-T/1 is depicted in Fig. 17.

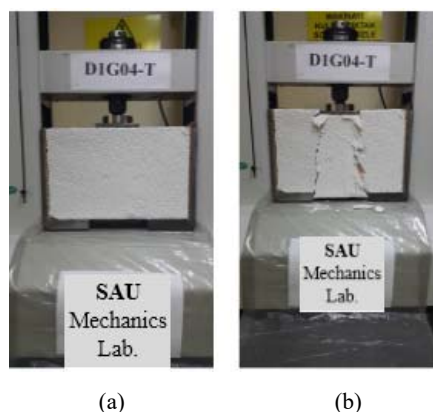
Fig. 16 (a) Initial state and (b) final state of D1G04-T/1

In the final phase of the study, the above mentioned strengthening system was applied to both surfaces of the three specimens and the results were analyzed comparatively. The thickness of the plaster on each surface was considered as 1 cm. The experiment set was named as D1G04-T. Initial and final states of D1G04-T/1 under shear force were in Fig. 16.

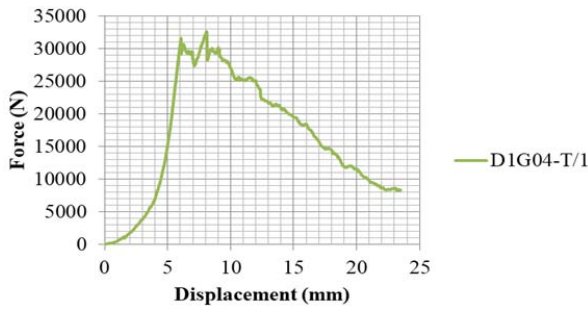
Fig. 17 Force-displacement diagram of the D1G04-T/1

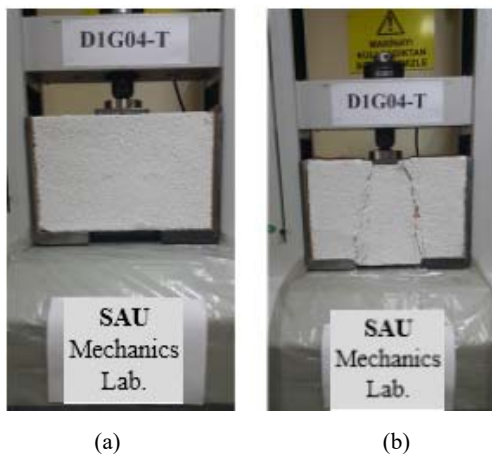
Fig. 18 (a) Initial state and (b) final state of D1G04-T/2

The second and third specimens of the D1G04-T set were also tested. At all specimens in this experiment group, it was obviously seen that the damage started in a similar way to the D1G03 set (Fig. 18).

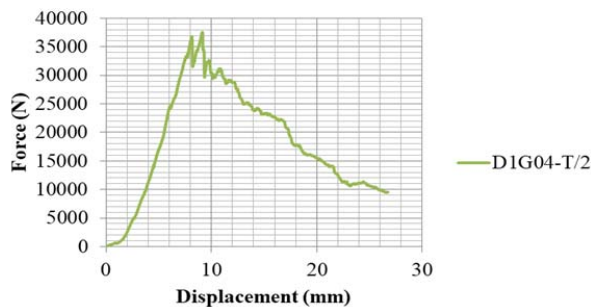
Fig. 19 Force-displacement diagram of the D1G04-T/2

The F_{max} values were determined for these specimens as 37544 N and 36394 N, respectively. The shear strengths were calculated as 0.340 MPa and 0.330 MPa, respectively. The experimental shear force-displacement curve for D1G04-T/2 and D1G04-T/3 are illustrated in Figs. 19 and 21.

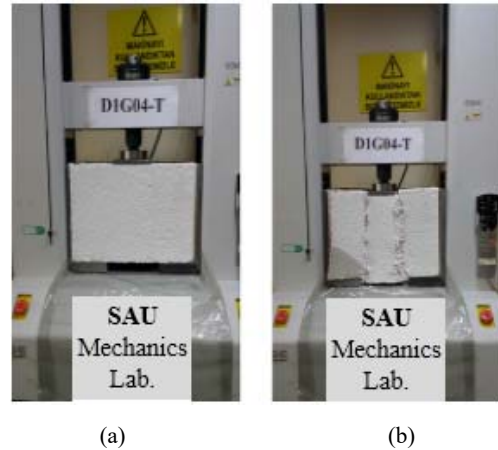
Fig. 20 (a) Initial state and (b) final state of D1G04-T/3

The failure modes of all plastered specimens were similar due to vertical cracks in the direction of loading, which followed the interface between the bricks and joint mortar (Fig. 20).

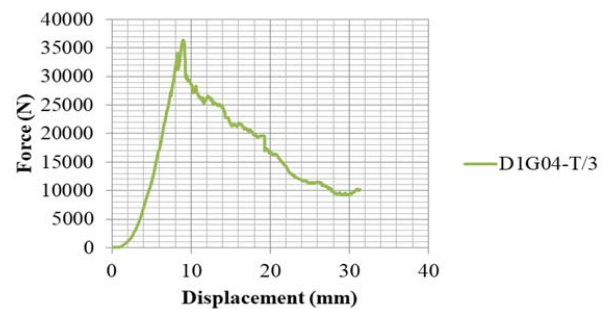
Fig. 21 Force-displacement diagram of the D1G04-T/3

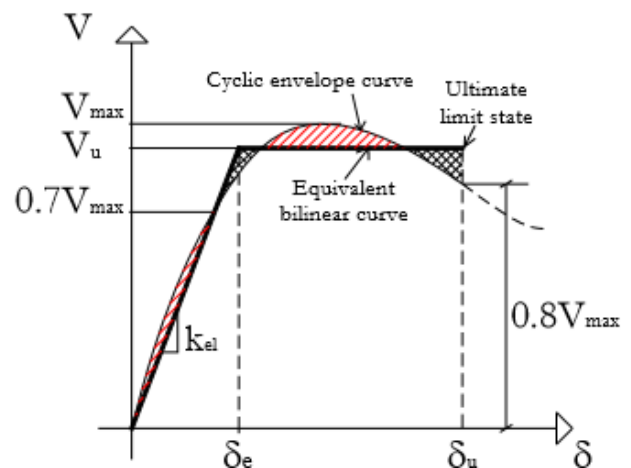
Fig. 22 Bilinear Idealization

Magenes and Morandi [11] calculated the ductility coefficients by idealizing the envelope curve obtained from the experiment with equivalent bilinear curves (Fig. 22). In a similar way, the energy-dissipation capacities of the samples were determined (3), with the force-displacement curves being idealized in this research.

$$\mu = \frac{\delta_u}{\delta_e} \quad (3)$$

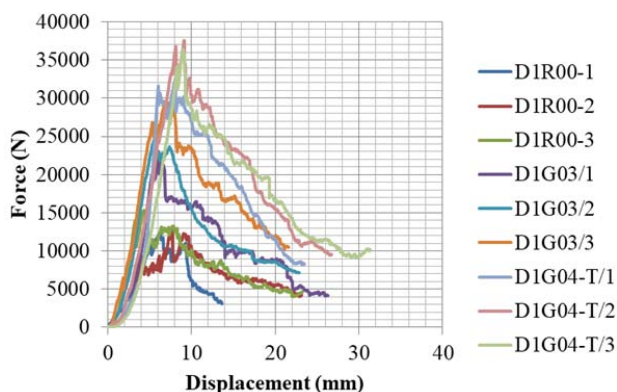
Fig. 23 Comparison of force-displacement diagrams

It is easy to see from the obtained ductility coefficients in Table III, D1G04-T coded samples exhibit a more ductile behavior compared to the other set of experiments (D1G03) and reference samples are insufficient in terms of load bearing capacity, shear strength and energy dissipation. The results of all triplet shear tests performed were compared in Fig. 23.
