Analysis of Possible Causes of Fukushima Disaster

Abid Hossain Khan, Syam Hasan, M. A. R. Sarkar

Abstract—Fukushima disaster is one of the most publicly exposed accidents in a nuclear facility which has changed the outlook of people towards nuclear power. Some have used it as an example to establish nuclear energy as an unsafe source, while others have tried to find the real reasons behind this accident. Many papers have tried to shed light on the possible causes, some of which are purely based on assumptions while others rely on rigorous data analysis. To our best knowledge, none of the works can say with absolute certainty that there is a single prominent reason that has paved the way to this unexpected incident. This paper attempts to compile all the apparent reasons behind Fukushima disaster and tries to analyze and identify the most likely one.

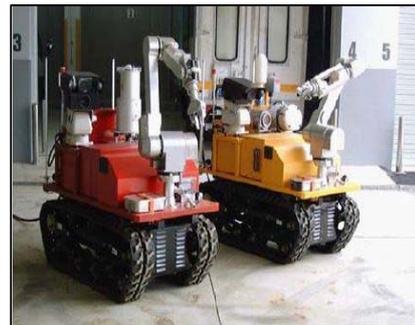
NUSTEC developed MoniRobo-A and MoniRobo-B; robots that could monitor the exterior of a building in which an accident had occurred JAERI, now the Japan Atomic Energy Agency (JAEA), developed two REmote Surveillance Squad (RESQ)-A robots that were anticipated to be able to acquire initial information, such as beta and gamma dose level

Fig. 4 MoniRobo-A and B [8]

Before Fukushima disaster, NUSTEC had kept MoniRobo-A and MoniRobo-B maintained. JAEA had stored RESQ-A, RESQ-B and RESQ-C but had not maintained them after 2006. These robots were not able to work as a result of some failures. The vendor that had co-operated when the robots were developed, was requested to repair RESQ-A, RESQ-B and RESQ-C, but the vendor refused the request because the engineer who had involved had since left, with the result that necessary information had been lost. During Fukushima disaster, NUSTEC sent MoniRobo-A to J-Village, which became the base for the emergency response to Fukushima Daiichi accident. However, it was not deployed because it was considered to be too heavy and could damage cables and hoses that were temporarily setup for electric power supply and water supply [8].

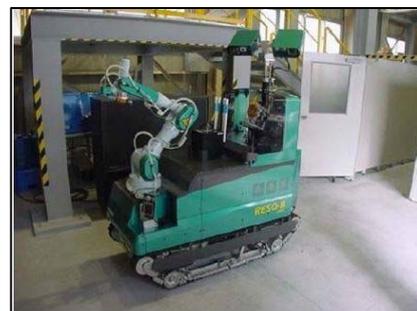
data and neutron data, a REAQ-B robot that was to acquire detailed information, a RESQ-C that was to acquire samples, and a Radiation proof roBOT (RaBOT) that could be resistant to radiation. These robots were planned to monitor the insides of buildings, when accidents have occurred in the buildings, so RESQ-B, RESQ-C and RaBOT were equipped with arms that could deal with opening door handles. MSTC developed an operation assistance robot SMERT-K for quick reconnaissance, an operation assistance robot SMERT-M which could carry SMERT-K and run over rubble, a light operation robot SWAN, an operation robot MARS-A, a heavy transporter robot MARS-T, and an anti-high radiation robot MENHIR [8].

Fig. 6 RESQ-B [8]

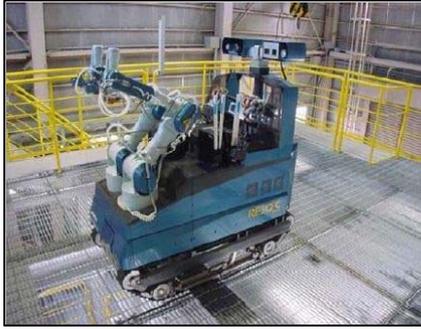
Fig. 7 RESQ-C [8]

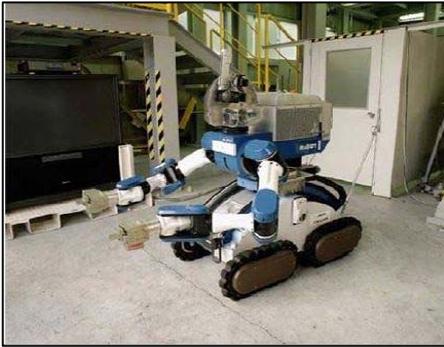
Fig. 8 RaBOT [8]

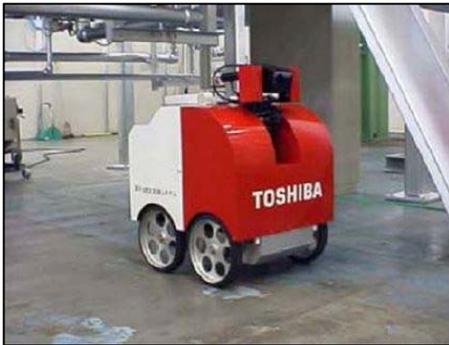
Fig. 9 SMERT-K [8]
