# Influence and Interaction of Temperature, H<sub>2</sub>S and pH on Concrete Sewer Pipe Corrosion

Anna Romanova, Mojtaba Mahmoodian, Morteza A. Alani

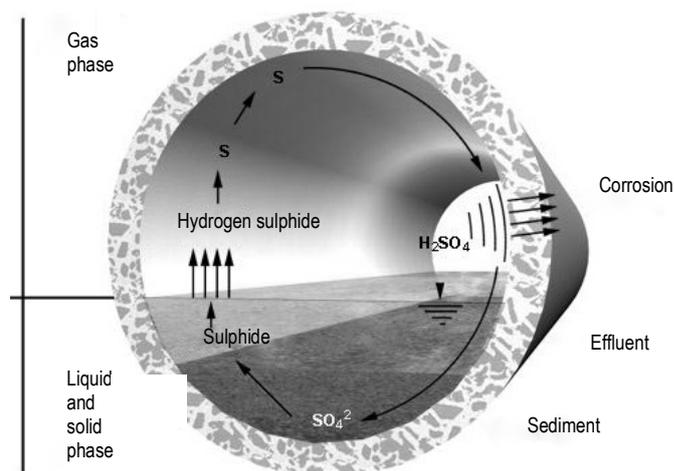
Fig. 1 Microbially induced concrete corrosion in sewer [19]

The process of sewer pipe corrosion has been studied since 1940<sup>th</sup> and a set of representative knowledge has been gained over years, which are referred to as microbially induced concrete corrosion (MICC) [12]. The bacteria class *Acidithiobacillus thiooxidans* [12]-[14] which are active in the effluent biofilm [15] convert sulphate to sulphide [16]. Some part of sulphide is released in atmosphere as gaseous hydrogen sulphide (H<sub>2</sub>S) [16]. Further, the hydrogen sulphide is oxidised [17] to sulphuric acid (H<sub>2</sub>SO<sub>4</sub>), which subsequently attacks susceptible pipeline materials [18]. Fig. 1 demonstrates the chemical reaction of microbially induced concrete corrosion process in sewer pipe.

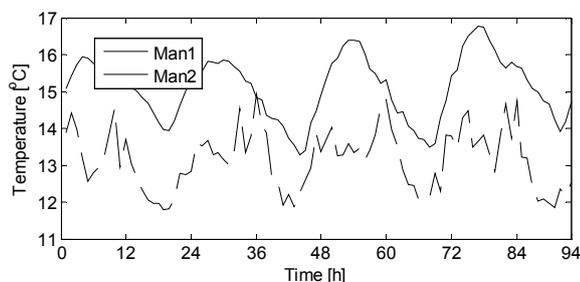
Fig. 1 Effluent temperature for Manhole 1 and Manhole 2 for a period of 4 days in the beginning of April shown in hours

The effluent temperatures for both manholes were found to follow very similar daily trend, however each of them has individual hourly pattern. Fig. 1 represents the data of effluent temperature recorded at a manhole 1 and manhole 2 in 5 days period in the beginning of April, where zero is set at 10am.

The data on Fig. 1 and for all other graphs was resampled to represent an average value for each given hour. Overall, in Feb-Apr the temperatures measurements minimum, maximum and mean for Man1 and Man2 were, 10.8°C, 17.1°C, 13.2°C and 11.6°C, 17.6°C, 15.1°C, respectively. In general the temperatures in Man2 are found to be higher and this is thought to be influenced by a closer location to the rising main, pumping station and generally the industrial sector which have larger use of hot water.

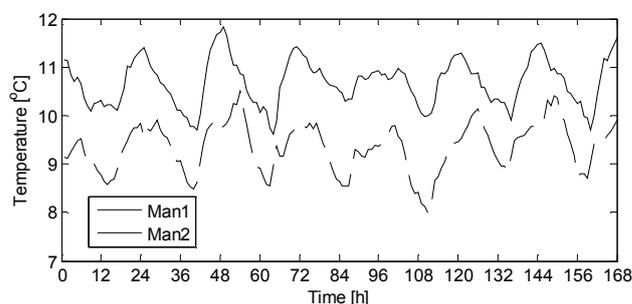
Fig. 2 Ambient temperature for Manhole 1 and Manhole 2 for a period of 1 week in the beginning of March shown in hours

The ambient temperatures for both manholes were found to follow overall an identical pattern. The general pattern of this behavior for both manholes is illustrated in Fig. 2, with zero set at midnight. From Fig. 2 it can be noted that the temperature in Man 1 is generally slightly lower for that compared with Man 2, with mean temperature values of 9.3°C and 10.6°C, respectively. Overall, in Feb-Apr the temperatures measurements minimum, maximum and mean for Man1 and Man2 were, 7.6°C, 12.9°C, 10°C and 8.7°C, 13.8°C, 11.2°C, respectively. The temperatures increased over the day with peak times at 11pm-4am after which they declined. This coincided with the discharge of overflow in the pumping station which generally takes place at midnight or when the chamber is full. However each manhole had manhole-specific minor pattern which is thought to be governed by house hold and industry activity in the area.

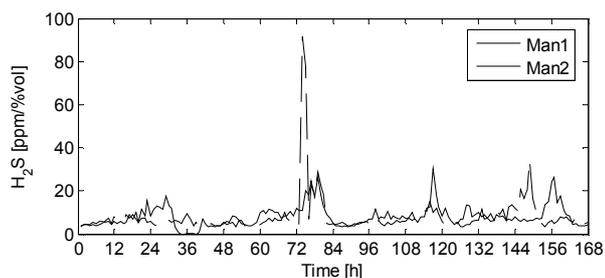
Fig. 3 Hydrogen sulphide concentration for Manhole 1 and Manhole 2 for a period of 1 week in the beginning of March shown in hours

The concentration of hydrogen sulphide for both of the manholes was measured with the sensor being placed in the middle of the manhole at 600mm above the effluent. The measurements of H<sub>2</sub>S are presented on Fig. 3, where the data is shown for the same time period as in Fig. 2. From the figure it can be noted that the pattern of H<sub>2</sub>S concentration is similar for both manholes even though they were located far apart and governed by different rising mains and pumping station conditions. Although, it should be noted that the operational time for all pumping stations in experimental area is the same. Graph identified large peak of H<sub>2</sub>S at Manhole 1 at 91ppm/ % vol, where manhole 2 identifies only 29ppm/%vol. A similar peak tends to appear app. every 48h closer to midnight.

Overall, in Feb-Apr the measurements of the  $H_2S$  concentration minimum, maximum and mean for Man1 and Man2 were, 3, 134, 12 and 0, 168, 12, respectively. Even though the minimum and maximum values of both of the manholes varied, the mean of 12ppm/%vol was observed in both, whereas in most of the times a value of 3-5ppm/%vol was recorded.

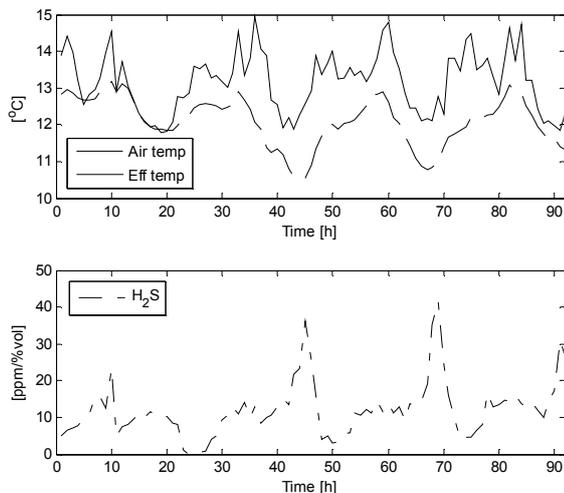
Fig. 4 Temperatures and hydrogen sulphide concentration for Manhole 1 for a period of 4 days in April shown in hours

The interaction between parameters of ambient temperature, effluent temperature and concentrations of hydrogen sulphide was investigated. Fig. 4 demonstrates the recorded data for the above for first four days in April for Manhole 1, with zero starting at 10am.

The data suggests that there is a relation between the ambient and effluent temperatures as they follow the same hourly pattern (which is governed by the effluent temperature, which in turn is related to domestic and industrial activities) and daily trend (governed by effluent temperature and general temperature of air outside the manhole). Furthermore, it can be noted that the  $H_2S$  level peaks together with the general decrease in temperature inside the manhole in late evening and early morning hours (during this time the general household and industrial activity is minimal, the flow levels are low to

moderate which allows for gas build-up). Furthermore, there is an apparent 10h shift in  $H_2S$  level increase and decrease behavior compared to temperatures. The above findings were confirmed for both of the manholes during Feb-Apr period.
