A Flute Tracking System for Monitoring the Wear of Cutting Tools in Milling Operations

Hatim Laalej, Salvador Sumohano-Verdeja, Thomas McLeay

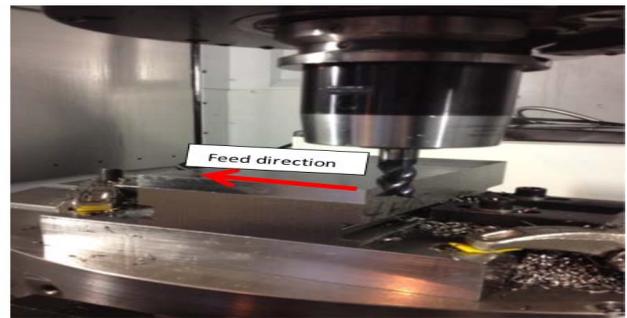
Fig. 1 Cutting path used in the experimental tests

along the path illustrated in Fig. 1 and using the cutting parameters shown in Table I. Figs. 5, 6 show the vibration signal along the X-axis (feed direction) measured by 604B31 tri-axial accelerometer and the displacement of the notch captured by the eddy current probe in these two cutting trials.

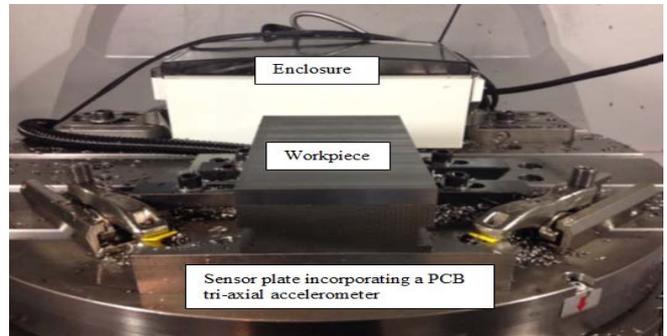
Fig. 2 Experimental set up of the DAQ system inside the machine tool

To monitor the cutting process, a data acquisition (DAQ) system developed by the Advanced Manufacturing Research Centre (AMRC) was used. This system comprises of two elements: a sensor plate mounted beneath the machined workpiece and an enclosure housing the additional electronics required for the sensor plate to function (National Instruments (NI) DAQ modules, power supplies, etc.). The sensor plate incorporates a number of sensors to capture the signals emitted during the cutting process including a 604B31 tri-axial accelerometer with 5KHz frequency range that measure the cutting vibration. The enclosure contains the National Instruments (NI) DAQ modules and the corresponding power

supplies to acquire data from 604B31 tri-axial accelerometer as well as the other sensors incorporated in the sensor plate. Note in this experimental study, only the vibration measured by the tri-axial accelerometer will be used to monitor the cutting process. The experimental set up of the DAQ system inside the machine tool is illustrated in Fig. 2.

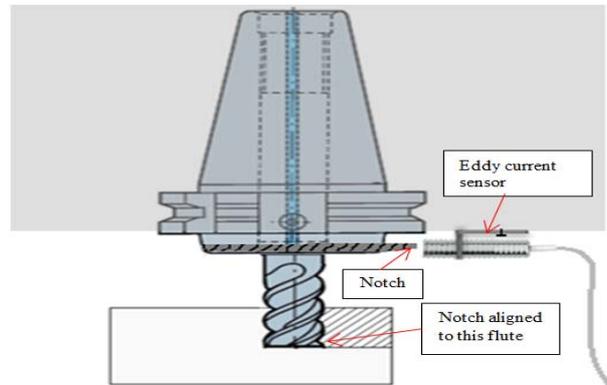
Fig. 3 Experimental set up of teeth tracking system

To track the vibration signal observed in each flute throughout the cuts, a flute tracking system was developed. This system consists of i) a Sensonic non-contact displacement sensor (eddy current probe) with a 10mm distance range fitted on the milling head and ii) a notch attached to the tool holder and aligned with one of the flutes in the cutter as shown in Fig. 3. The basic working principle of the flute tracking system is as follows. Each time the tool completes a full rotation, the non-contact displacement senses the distance to the top tip of the notch. Since the notch is aligned to one flute as shown in Fig. 3, the signals relating to this particular flute can be tracked throughout the cuts. Consequently, by using this tracked flute as a reference, the other two flutes can easily be identified throughout the cuts.

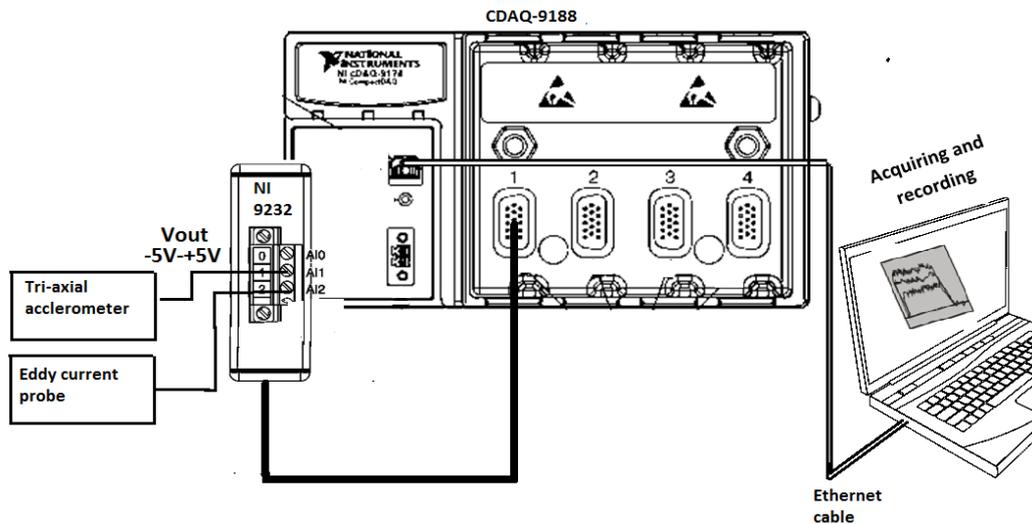
Fig. 4 A schematic diagram of data acquisition hardware

In this study, the vibration and eddy current signals were sampled at 51200 KHz using National Instrument (NI) 9232 DAQ module. A Compat DAQ chassis (CDAQ) with 8 slots (9188) was used to host 9232 DAQ module via one of its slots. The DAQ module has 3 A/D channels (all being of 24 bits resolution) to perform the discretization of sensor measurements. Following the sampling and discretization of the sensor signals, the data was passed to the computer through an Ethernet port. A virtual instrument based on LabVIEW software was developed to read and store the discretised time-sampled data captured by NI DAQ hardware in the computer

local disk in LabVIEW file format (TDMS format). A schematic diagram of the experimental set up is shown in Fig. 4.

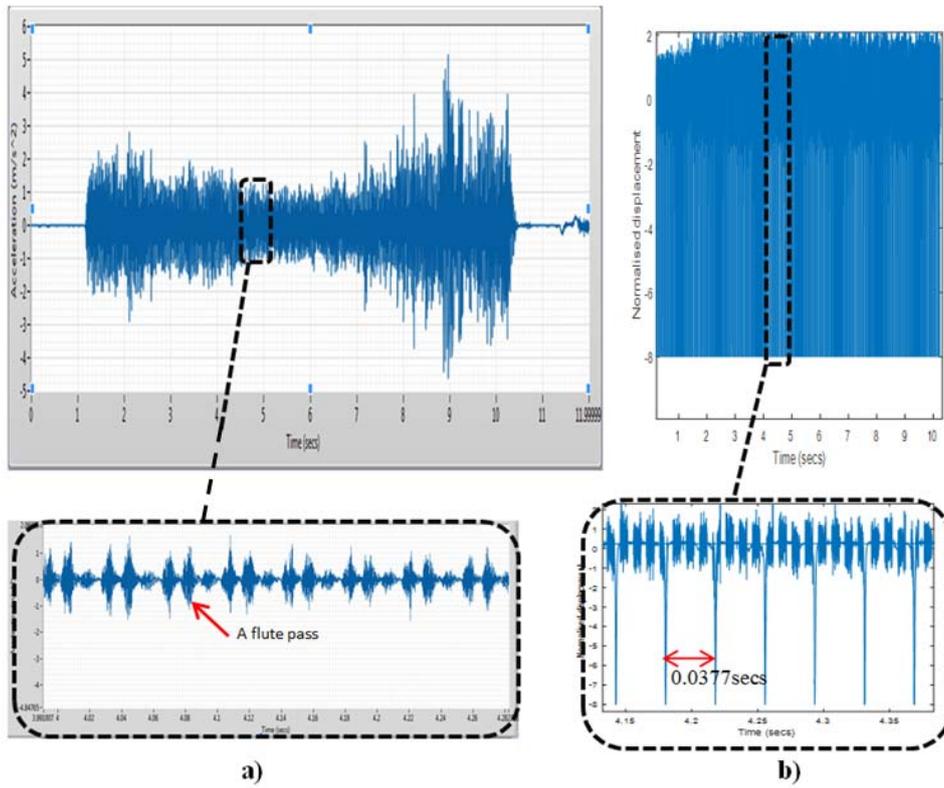
Fig. 5 The results obtained in cut #1: (a) Flute passes observed in the acceleration signal along the X-axis (b) Displacement measured by the eddy current sensor

It can be seen from Figs. 5 (a) and 6 (a) that due to the discontinuous nature of the cutting process (only one flute is in contact with the workpiece at one time), each flute pass can be identified and observed in the accelerometer signal in cuts #1 and #2. Although it is possible to track the three flutes of the cutter in cut #1 by assigning flute passes observed in the acceleration signal to individual flutes of the cutting tool, it is extremely difficult if not impossible to keep track of these flutes in cut #2. This in turns makes the task of monitoring the wear on individual flutes throughout the cuts an impossible one to achieve in practice. It can be observed from Figs. 5 (b) and 6 (b) that the displacement results fluctuate significantly between the valleys. These fluctuations in the sensor signal are basically external noises introduced during machining and they are probably caused by the rattling of the sensor at the attachment

point when the cutting tool is in contact with the workpiece. It can be also noticed from Figs. 5 (b) and 6 (b) that the valleys in the displacement results occur at 0.0377secs intervals which is the time needed for the cutting tool to complete one full rotation with the selected spindle speed (1592 RPM) for the experimental tests as depicted in Table I. This result was anticipated, as the eddy current probe measures the distance to the top tip of the notch only when the notch attached to the tool holder is aligned with the eddy current sensor. This obviously occurs after the cutting tool completes one full revolution. The displacement measurements are therefore taken at regular intervals (one complete rotation), thus creating valleys in the results. It is also worth pointing out that the flute tracking system is essentially a tachometer as it measures the spindle speed as discussed above.

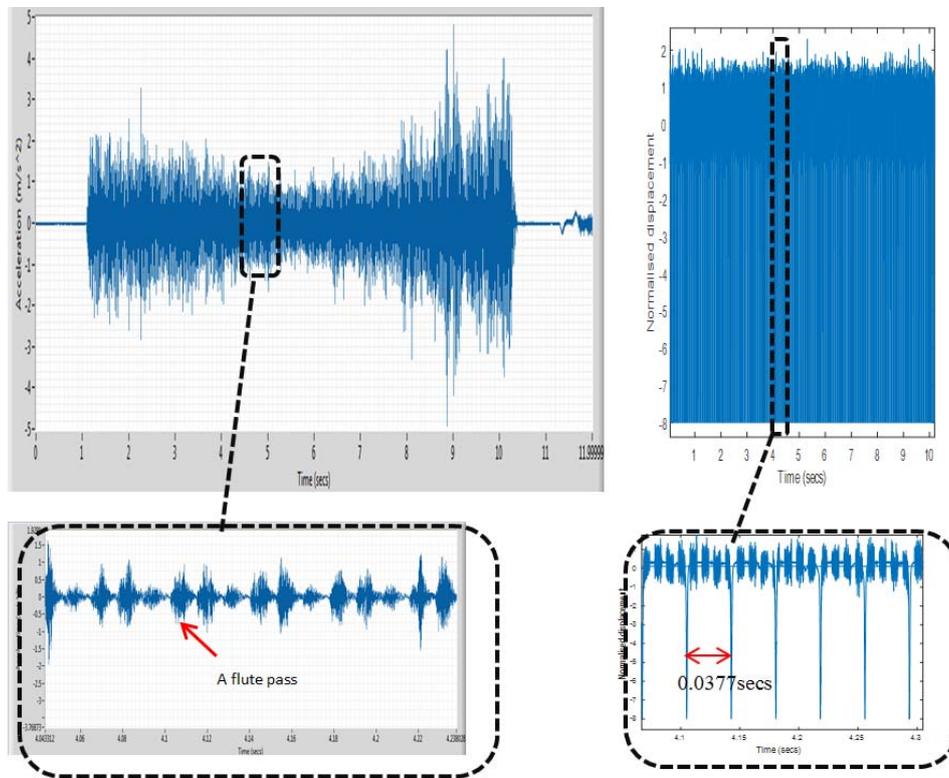
Fig. 6 The results obtained in cut #2: (a) Flute passes observed in the acceleration signal (b) Displacement measured by the eddy current sensor

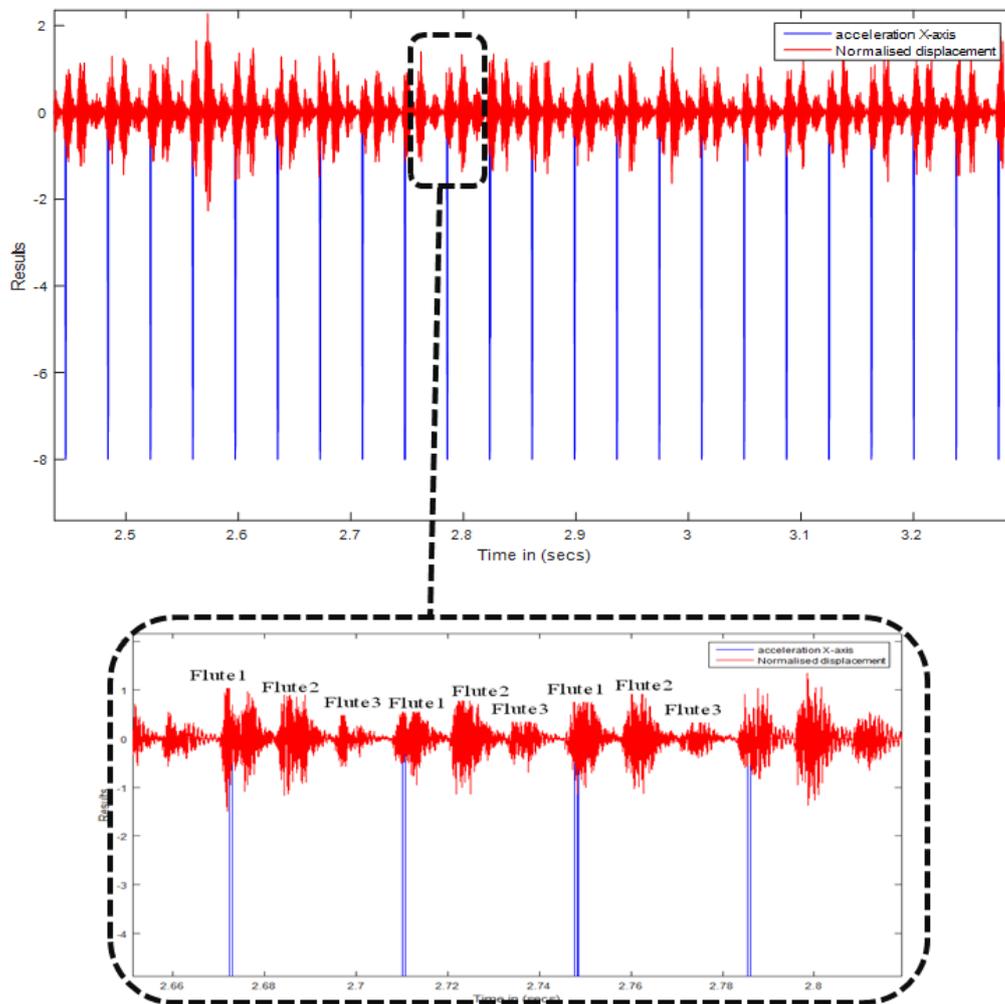
Fig. 7 The segmentation of acceleration signal by flute using teeth tracking system in cut #1

As mentioned in Section II, the notch was deliberately designed to be aligned to one of the cutter flutes to aid tracking of this particular flute throughout the cuts. Hence, by using this tracked flute as a reference, the other two flutes can easily be identified throughout the cuts. To demonstrate this concept, the flute tracking system was used to segment the acceleration

signal by flutes in the two cuts shown in Figs. 5 and 6. The results are shown in Figs. 7 and 8 which clearly confirm that the flute tracking system is capable of identifying each physical flute of the cutting tool in these two cuts. Thus, by segmenting the vibration signal by flutes, it is therefore possible to monitor the wear in the individual flutes separately throughout the cuts.

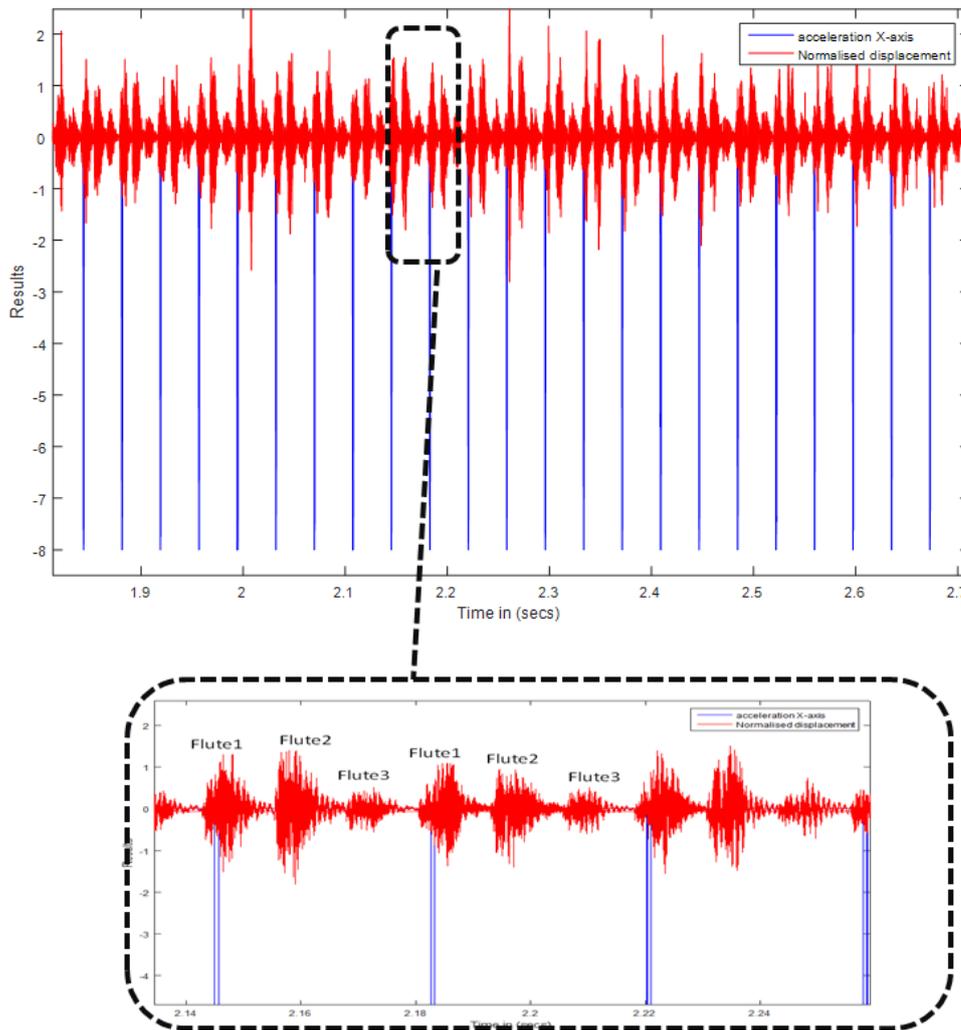
Fig. 8 The segmentation of acceleration signal by flute using teeth tracking system in cut #2

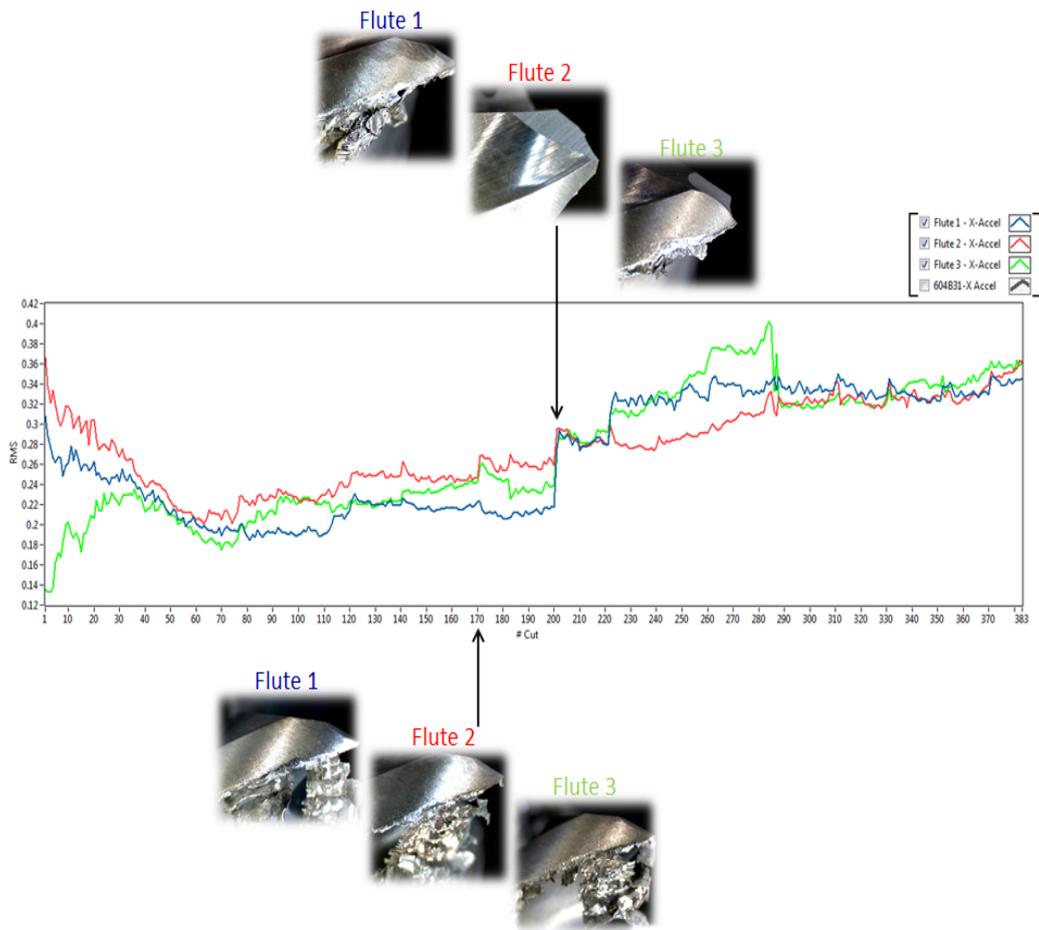
Fig. 9 RMS of X-axis acceleration signal by flute and microscopic image of flutes in cuts #170 and #200

To illustrate this idea, 382 additional cutting tests were performed along the same tool path and using the same cutting parameters as depicted in Table I. The RMS of the acceleration signal in each cut was then calculated for individual flutes of the cutting tool to monitor their progressive wear throughout the cuts. The acceleration results along the X-axis (feed direction) together with microscopic images of the tool at cuts #170 and #200 are shown in Fig. 9. It can be observed from this figure that from cuts #1 to #200, the RMS of the acceleration signal in flute 1 is higher than those in flutes 2 and 3. This might be explained by the fact that the cutting process is not uniform for all the flutes, with flute 1 engaging more with the workpiece

and removing more material in one revolution than the other two flutes. Moreover, it can be seen from this figure that when flutes 2 and 3 were broken at cut #200, there was a sudden rise in the RMS signal of flute 1. This increase in the RMS value of flute 1 can be attributed to the higher contact between the workpiece and the tool which occurred to compensate for the loss of contact by the other two flutes. Hence, the rise in the RMS of flute 1 provides a strong indication that the other flutes of the cutting tool were damaged. Similar behaviour was also observed in the average power of X-axis acceleration over a range of frequency [10, 5000Hz] as shown in Fig. 10.

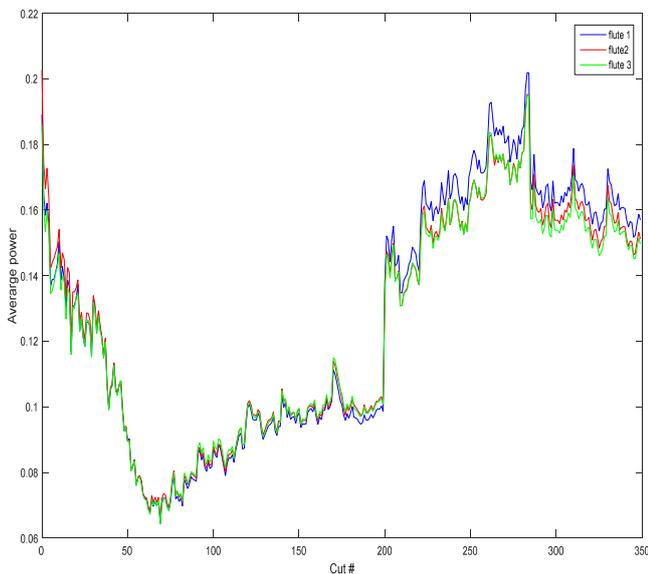
Fig. 10 Average power of X-axis acceleration over a range of frequency [10, 5000Hz]
