# Analysis and Preservation of Lime-Kilns in Corsica

A. Papalou, K. Vozikis

**Abstract**—The aim of this paper is the analysis and preservation of lime kilns, focusing on the structure, construction, and functionality of vertical shaft lime kilns of the Cap Corse in Corsica. Plans and sections of two lime kilns are presented in detail, providing an overall picture of this specific industrial heritage. The potential damage areas are identified performing structural analysis of a lime kiln using the finite element method. A restoration and strengthening technique that satisfies the directions of the Charter of Venice is presented using post-tensioning tendons. Recommendations are given to preserve and promote these important historical structures integrating them into the custom footpath.

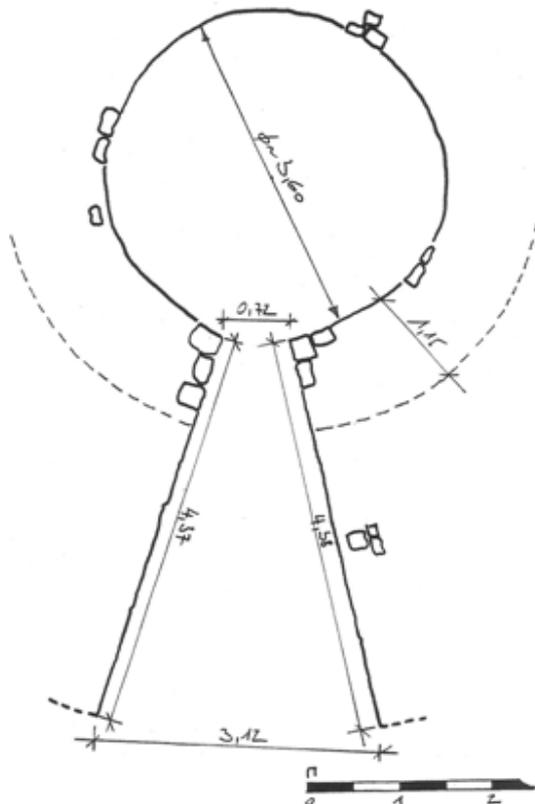
Fig. 7 Ground plan of Lime Kiln 2

Lime kiln 2 (Fig. 6) also belongs to the Community of Rogliano and is located next to lime kiln 1. This lime kiln is much smaller than lime kiln 1. The inside diameter of the kiln's shaft measures only 3.6 m, and is constant from bottom to top (Fig. 7). This structure has also been partly built into the hillside. The rest of the kiln form walls built with mortar of 1.15 m wide. An entrance foyer is still visible, but not so well maintained. The entrance width is about 3 m and the distance from the corridor to the firing door almost 4.5 m. The firing door is 0.72 m wide and 1.60 m tall and is better preserved than the previous one (Fig. 8). The firing door dimensions of these two lime kilns are similar, although the shaft's dimensions vary considerably. The shaft of this kiln is in good condition in contrast to the outside part of the foyer. The kiln's height is today approximately 5 m. Two wooden beams still exist at the firing door opening. Lime kiln 2 was probably using the same quarry as lime kiln 1. This kiln is also visible and easily reachable from the custom footpath although its outside part is completely covered by maquis.
