Motor Gear Fault Diagnosis by Current, Noise and Vibration on AC Machine Considering Environment

Abstract—Lots of motors have been being used in industry. Therefore many researchers have studied about the failure diagnosis of motors. In this paper, the effect of measuring environment for diagnosis of gear fault connected to a motor shaft is studied. The fault diagnosis is executed through the comparison of normal gear and abnormal gear. The measured FFT data are compared with the normal data and analyzed for q-axis current, noise and vibration. For bad and good environment, the diagnosis results are compared. From these, it is shown that the bad measuring environment may not be able to detect exactly the motor gear fault. Therefore it is emphasized that the measuring environment should be carefully prepared.

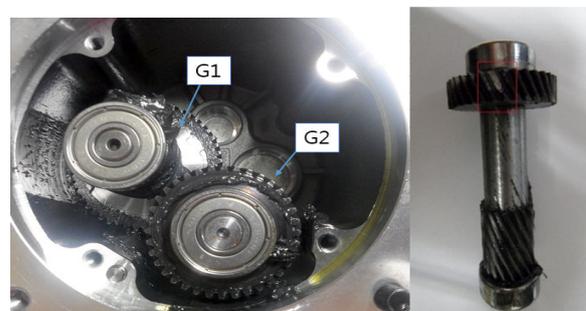
Fig. 1 Damaged gear box and damaged gear teeth

Helical gears are used in the test gear box. This gear box is connected with 3-phase induction motor and the gear box shaft is coupled with mechanical load or AC servo motor as a load. There are 4 gears in the box as shown in Fig. 1. Fig. 3 shows the inner structure of the gear box and the gear position. The axis rotating frequency can be found by the number of teeth of each gear. The number of poles for test motor is 4. The frequency of each axis is as follows where frequency f is the applied voltage frequency [5].

The frequency of axis 1 f_{ax1} is approximately half of the applied voltage frequency f because the number of pole of the motor is 4. In this study, gear G2 is damaged as shown in Fig. 1. With these equations, the gear fault can be analyzed by measuring the vibration frequencies [5].

Fig. 7 shows the FFT results of vibrations for x, y axis and vector sum. As shown in Fig. 1, the fault gear is G2 which is associated with the axis 2. From (1)~(3), the frequency of axis 2 is 5.69Hz. As shown in Fig. 7 (c), especially big vibration data are measured at 6Hz, 11Hz, 17Hz, 21Hz and 28Hz. Those frequencies are approximately multiple times of base frequency 5.69Hz.

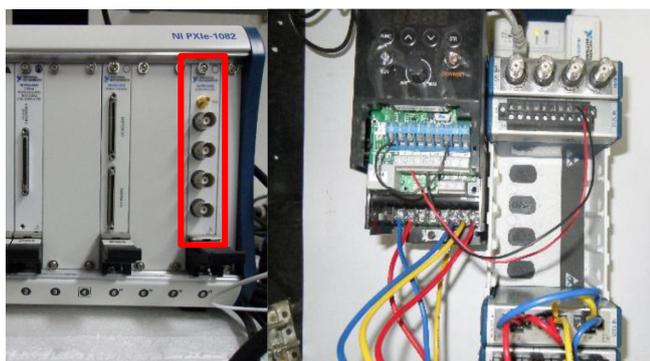
Fig. 2 shows the measuring device and inverter system. The left one is the measurement device for three-phase line-to-line voltage, current, noise and vibration data etc. The right one is the 3-phase inverter to drive the test induction motor. For measuring the line to line voltage, NI-9225 is used, for phase current, NI-4462 is used. For vibration and noise measurement, NI-PXI9234 is used with high precision mic and amplifier. The accelerometers whose sensitivities are 100 mV/G and 10mV/G are used. The measuring software is developed with LabVIEW for data collection [5] and is modified for better performance.

Fig. 2 DAQ and Inverter

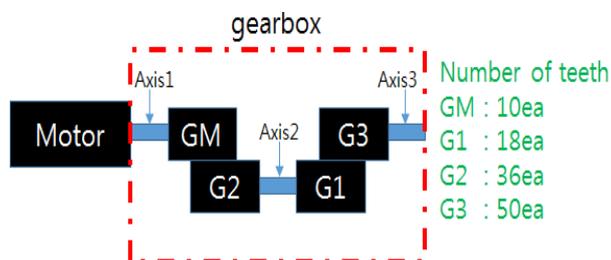
Fig. 3 Gear box structure

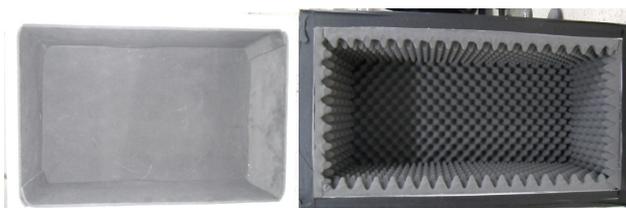
In this section, the environment of the measuring system is discussed. The measured data includes noise and vibration as well as q-axis current. Measuring the noise means that the device measures sound. Sound comes from not only motors and gears but also from so many sources like computer fans, voice, winds and etc. If the sound isolation is not enough, the measured data includes many kinds of sounds and some of them are not related with motor and gears. Fig. 4 shows the sound isolation covers. Fig. 4 (a) shows thin cover and Fig. 4 (b) shows doubly isolated cover. The measured data would be different according to the sound isolation covers.

(a) Thin single isolation cover (b) Thick doubly isolated sound cover

Fig. 4 Sound isolation covers

Fig. 9 shows the FFT of sound noise data when the inverter frequency is 60Hz. Fig. 9 (a) shows the FFT of the sound noise when the sound isolation is not enough as explained in Fig. 4 (a). Fig. 9 (b) is the same case under the good sound isolation condition covered with thick isolator. Those frequencies are approximately multiple times of the operating frequency 60Hz. As can be seen, it is not easy to find the periodicity in Fig. 9 (a) because it includes external noise sounds. Fig. 9 (b) shows much clearness and the periodicity and critical points can be easily found.

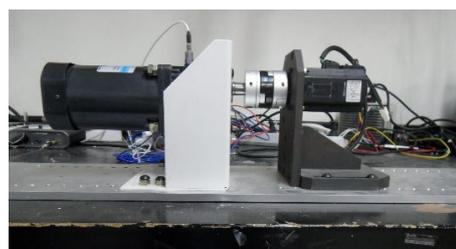
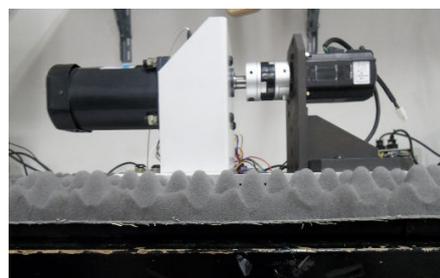
Fig. 5 shows the motor-load set on the table. Fig. 5 (a) shows the motor set is on the wood desk and it cannot isolate the vibration from the table. On the contrary, in Fig. 5 (b), the motor set is on rubber vibration isolator and sound isolator to cut off the outside vibrations.

(a) Motor-load set on wood desk

(b) Motor-load set on rubber vibration isolator and sound isolator

Fig. 5 Motor-load set under bad and good conditions

Fig. 8 shows the vibration of the gear box when the motor set is on the desk or on the rubber isolator as mentioned in Fig. 5. At first, the experiments are desired to have same results but the results are very different. That means the fault diagnosis may have wrong results if the measuring condition is not good enough.

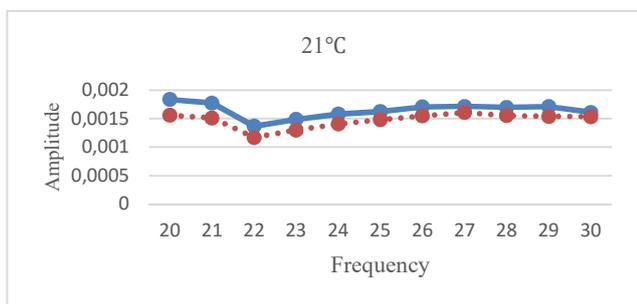
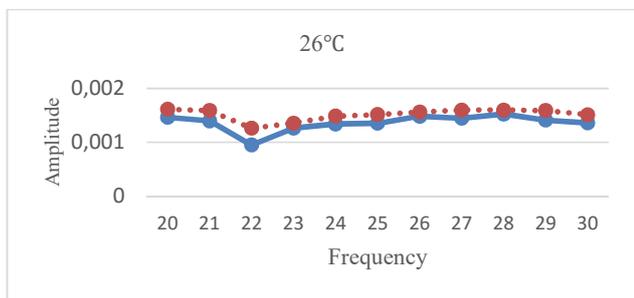
For the 2 case of ambient temperature of 21°C to 26°C, the q-axis current measurements are executed. Fig. 6 (a) shows the amplitudes of q-axis current for normal and fault gear boxes by adjusting the inverter frequency of 20Hz~30Hz under 21°C. Fig. 6 (b) shows the same case data when the ambient temperature is 26°C. Those data show somewhat different aspect between normal and abnormal gears. When the ambient temperature is low, the amplitudes of the normal data are larger than abnormal data. On the contrary, if the ambient temperature becomes high, abnormal data are larger than normal ones. From this experiment, it is found that the temperature condition cannot be ignored in this kind of measurements. It is found that the ambient temperature may influence the data in the process of collecting data at the experiment.

(a) Currents comparison under 21°C

(b) Currents comparison under 26°C

Fig. 6 Motor currents under 21, 26°C (solid line: normal, dotted line: fault gear)

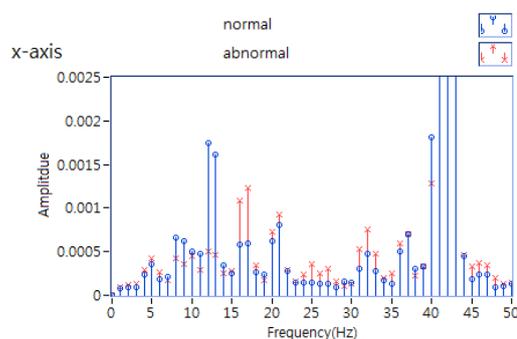
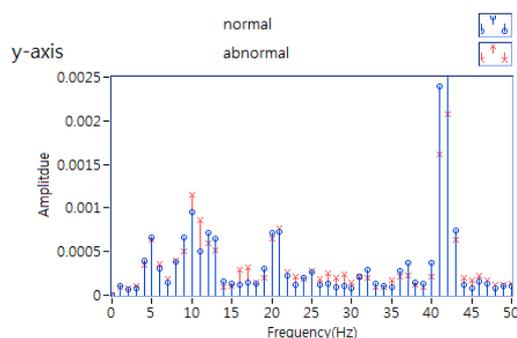
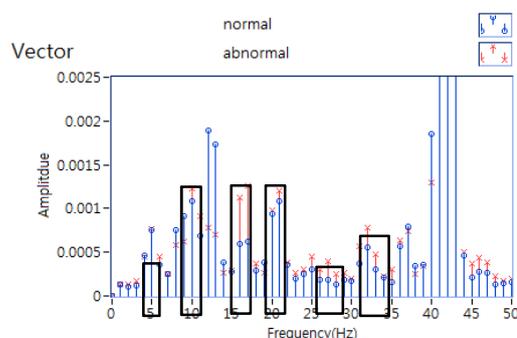
(a) FFT of x-axis Vibration

(b) FFT of y-axis Vibration

(c) Vector summation of x and y axis vibration

Fig. 7 FFT of vector sum of x and y-axis Vibration

In the figures, the frequencies of FFT results are expressed in integer, and the fault frequencies are not exactly multiple times. However the fault frequency can be easily estimated because the axis frequency is already known from (1)~(3).

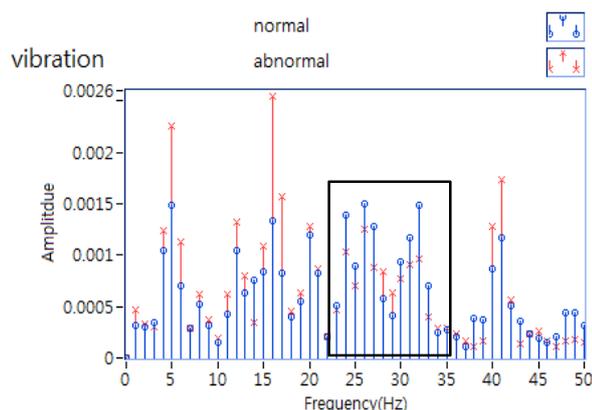
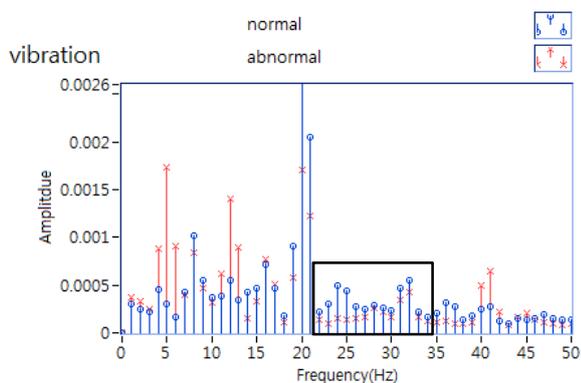
(a) Measured vibrations when the set is on wood desk

(b) Measured vibrations when the set is on vibration isolator
 Fig. 8 Vibration comparisons according to vibration isolator

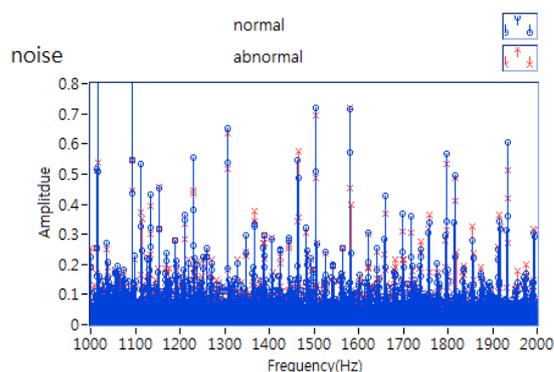
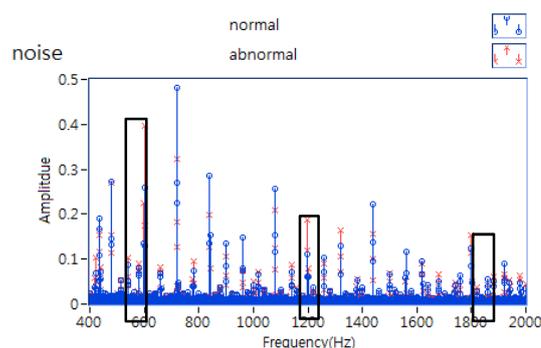
(a) Noise FFT when the set is in thin isolation cover

(b) Noise FFT when the set is in thick isolation cover

Fig. 9 Noise comparisons according to sound isolator thickness
