# Experimental and Finite Element Study of Bending Fatigue Failure: A Case Study on Main Shaft of a Gyrator Crusher

**Abstract**—This study investigates the mechanism of a Gyratory crusher-located in Golgohar mining and industrial Co. specifically with a focus on stresses distribution and fatigue failure of its main shaft. At first step, the cross section of the fractured shaft is studied, and the crack growth is analyzed. Then, the rotational motion of the shaft and the oil temperature of oil circuit of equipment are monitored. Condition monitoring is used to help finding a better modification. Based on the results of this study, the main causes of shaft failure are identified, and corrective solution is offered to increase crusher performance, especially its main shaft life. To predict the efficiency of the proposed modification, finite element simulation is performed, and its results are compared with the similar modified cases. The comparison and interpretation of simulation results confirm the efficiency of proposed corrective method.

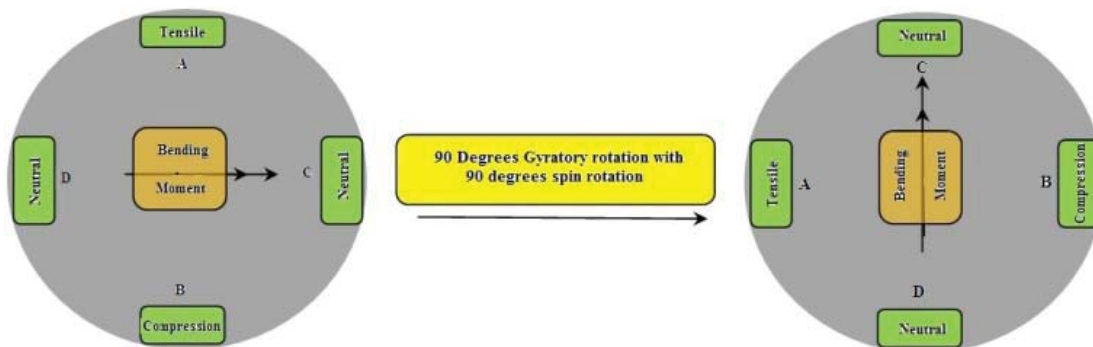
Fig. 5 Stress condition when Gyratory movement and rotational spin are synchronized

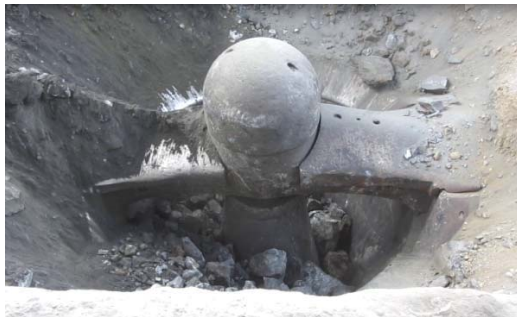
To justify our prediction on spin rotation effect, for a while shaft movement and feeding of crusher was shot in different working condition. Also, oil temperature is shot by thermo-vision camera in critical points at different times. Fig. 6 shows how the crusher is charged by iron Ore. In this study, it was found that the when crusher is charged, the spin rotation stops and during the period of crushing, almost gyratory movement dominates. However, gradually by passing the crushed Ore toward output and crusher unloads, spin rotation increases gradually. In Fig. 7, diagrams of shaft spin-rotational speed verses different times are plotted. The mentioned speed is recorded about two minutes after charge of ore simultaneous with the complete exit of ore. It can be seen when iron ore completely leaves the crushing area, spin rotational speed varies between 12 to 18 rpm on different dates. This speed approaches its asymptotic value about 30 rpm three minutes after exit of ore. It is interesting that this value is a proper fraction of gyratory speed (120 rpm). Therefore, it can be concluded that probably a direct contact happens between shaft and bottom eccentric bushing or oil shear strength between contact surfaces forms frictional torque which leads to spin rotational of shaft. Objective observation of surface of bushing and shaft circumstance indicates damages in these areas, which confirms above-mentioned hypothesis.

Fig. 6 A view of input of crusher in which charged with iron ore
