Lubrication Performance of Multi-Level Gear Oil in a Gasoline Engine

Abstract—A vehicle gasoline engine converts gasoline into power so that the car can move, and lubricants are important for engines and also gear boxes. Manufacturers have produced numbers of engine oils, and gear oils for engines and gear boxes to SAE International Standards. Some products not only can improve the lubrication of both the engine and gear box but also can raise power of vehicle this can be easily seen in the advertisement declared by the manufacturers. To observe the lubrication performance, a multi-leveled (heavy duty) gear oil was added to a gasoline engine as the oil in the vehicle. The oil was checked at about every 10,000 kilometers. The engine was detailed disassembled, cleaned, and parts were measured. The wear of components of the engine parts were checked and recorded finally. Based on the experiment results, some gear oil seems possible to be used as engine oil in particular vehicles. Vehicle owners should change oil periodically in about every 6,000 miles (or 10,000 kilometers). Used car owners may change engine oil in even longer distance.

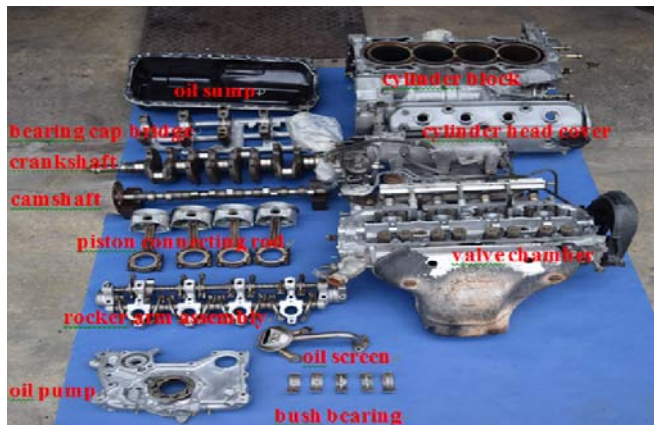
parts showed serious evidence of oil engine sludge such as the lead ring of oil filter, oil pan and oil filter, piston rod, rocker chamber, and so on. Oil sludge is caused by reduced oil lubricating ability and affects the efficient operation of an engine. Fig. 3 shows the disassembled engine parts after completion of the experiments. All parts were reassembled after undergoing a thorough cleaning and the engine was then checked in accordance with the Honda Accord Service Manual [7]. Cylinder block warpage was checked using a feeler gauge, and results are shown in Table I [7]. Cylinder block warpage was within the normal range when compared with the standard value range. Cylinder block bore taper was checked using a cylinder bore gauge, the results of the measurement were recorded in Table II [7]. The results show that the cylinder block bore taper value for A and B was higher than the standard value indicating wear. Piston diameter was examined, and the piston rings end gap was checked using a feeler gauge, the results were recorded in Table III [7]. The third ring was not measured because it had already seized. Piston diameters were slightly smaller than new ones, while the piston rings end gap were smaller, too. The second ring end gap was much smaller, and this may be owing to the deformation of the piston rings which operated in extremely high engine temperatures for an extended period of time. The crankshaft main journal diameter

Fig. 3 Disassembled engine parts

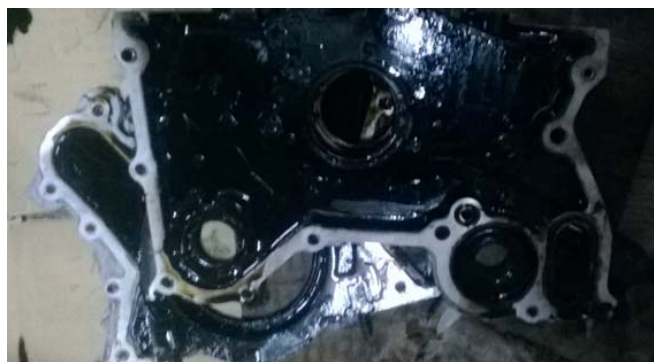
was checked and the data recorded in Table IV [7]. The crankshaft main journal diameter value was normal. The connecting rod journal bore taper was recorded in Table V [7], and was also in the normal range. The camshaft lobe height was recorded in Table VI [7]. Fig. 4 illustrates the contaminates and sludge accumulated in the oil pump. Fig. 5 shows the contaminates and sludge accumulated on the oil screen. Fig. 6 reveals the contaminates and sludge accumulated around the oil sump. Fig. 7 shows the contaminates and sludge accumulated around the cylinder and engine chamber and the inner oil guide. Fig. 8 illustrates the dissembled pistons and connecting rods. Fig. 9 reveals damage to the bush bearing on the right hand side. Most engine parts were considered worn or damaged beyond repair such as the oil filter, third piston ring, and bush bearing. The sludge produced in the engine hindered the flow of the oil feed lubrication system. Sludge clogged the sump oil strainer, which resulted in insufficient lubrication leading to a build-up of sludge and carbon in the pistons. High oil temperature also caused the piston rings to lose elasticity and seize. Carbon accumulation and oxidation deposition could happen in the engine combustion chamber. Long-term accumulation of sludge brought out oil deterioration, which resulted in vicious oil, lower liquidity, and insufficient cooling.

Fig. 4 Contaminates and sludge accumulated in the oil pump

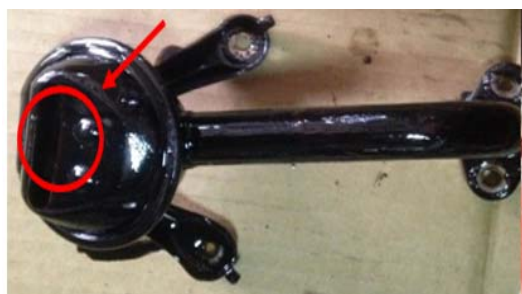
Fig. 5 Contaminates and sludge accumulated on the oil filter

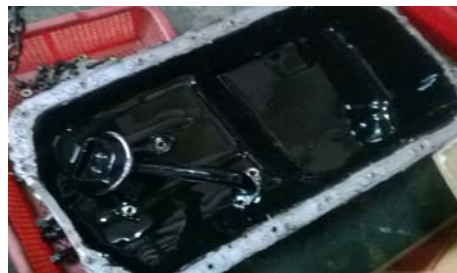
Fig. 6 Contaminates and sludge accumulated in the oil pump

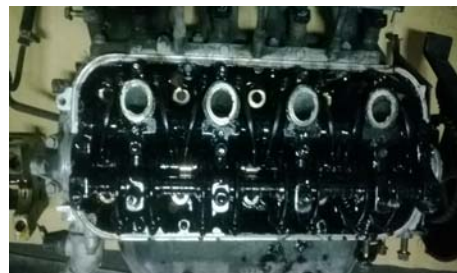
Fig. 7 Contaminates and sludge accumulated around the cylinder and engine chamber and inner oil guide

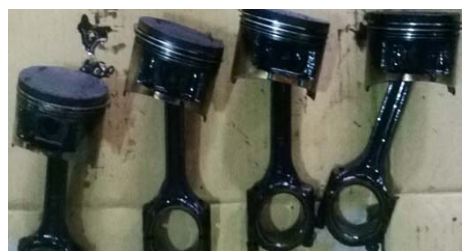
Fig. 8 Disassembled pistons and connecting rods

Piston diameters and piston rings end gaps were smaller compared to new ones. Deformation of the piston rings did occur, which may be the result of the engine operating over a long period at an extremely high temperature without an oil change.

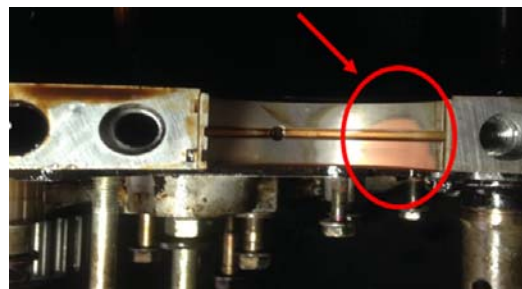
Fig. 9 Bush bearing shows damage on the right hand side after 100,000 km

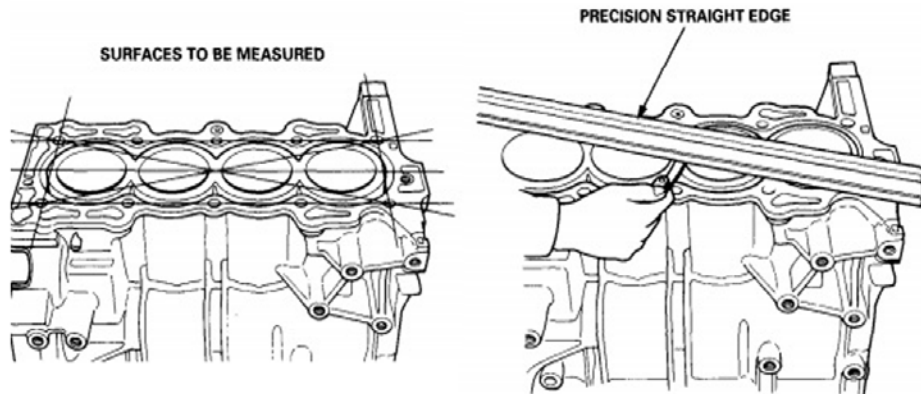
Check the top of the block for warpage.
 Measure along the edges and across the center as shown.

Engine Block Warpage:
Standard (New): below 0.07 mm (0.003 in) max.
Service Limit: 0.10 mm (0.004 in)

Fig. 10 Measurement of cylinder block warpage [7]

Fig. 10 revealed measurement of cylinder block warpage. Measurement of cylinder block bore taper was illustrated in Fig. 11. Measurement method of piston diameter and piston rings end gap was illustrated in Fig. 12. While the measurement of crankshaft main journal diameter and clearance was described in fig. 13. Fig. 14 shows measurement of connecting rod journal and clearance. Measurement of Camshaft height clearance was illustrated in Fig. 15.

Cylinder Block Warpage (mm)	1	2	3	4	5	6	Service limit
	0.03	0.015	0.03	0.03	0.05	0.05	0.10

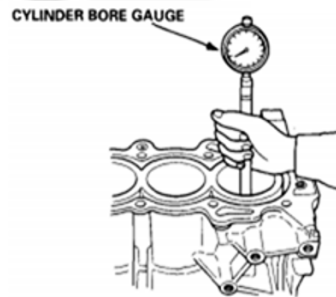
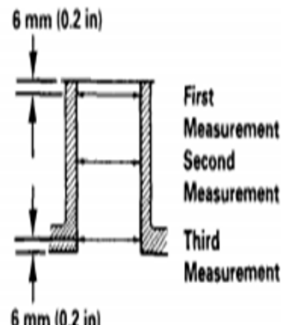
Measure wear and taper in direction X and Y at three levels in each cylinder as shown.

Cylinder Bore Size:
Standard (New):
 A or I: 85.010 – 85.020 mm (3.3468 – 3.3472 in)
 B or II: 85.000 – 85.010 mm (3.3465 – 3.3468 in)
Service Limit: 85.070 mm (3.3492 in)

Fig. 11 Measurement of cylinder block bore taper [7]

Cylinder block bore taper (mm)	1	2	3	4	Standard
Bore A	85.26	85.22	85.24	85.22	85.010
Bore B	85.25	85.25	85.23	85.24	85.000
Taper AB	0.01	0.03	0.01	0.02	0.005

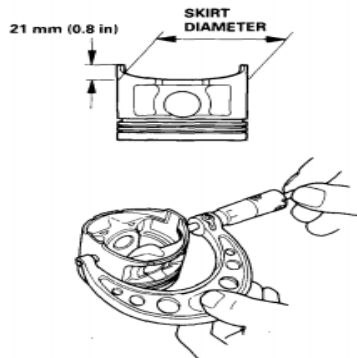
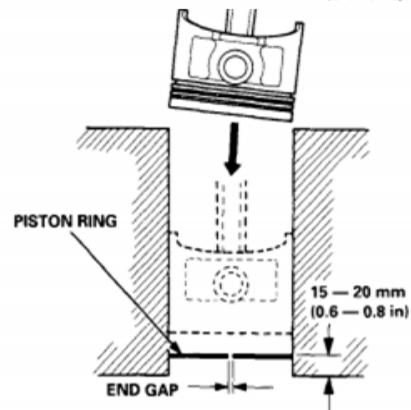
Piston Diameter:
Standard (New):
 No Letter (A): 84.980 – 84.990 mm (3.3457 – 3.3461 in)
 B: 84.970 – 84.980 mm (3.3453 – 3.3457 in)
Service Limit:
 No Letter (A): 84.970 mm (3.3453 in)
 B: 84.960 mm (3.3449 in)

Piston Ring End-Gap:
Top Ring
Standard (New): 0.20 – 0.35 mm (0.008 – 0.014 in)
Service Limit: 0.60 mm (0.024 in)
Second Ring
Standard (New): 0.40 – 0.55 mm (0.016 – 0.022 in)
Service Limit: 0.70 mm (0.028 in)

Fig. 12 Measurement method of piston diameter and piston rings end gap [7]

piston diameter (mm)	1	2	3	4	Standard
	84.960	84.965	84.960	84.970	84.980~84.990
piston rings end gap	Standard				
top ring	0.19	0.19	0.19	0.19	0.2~0.35
Second ring	0.24	0.24	0.24	0.24	0.4~0.55

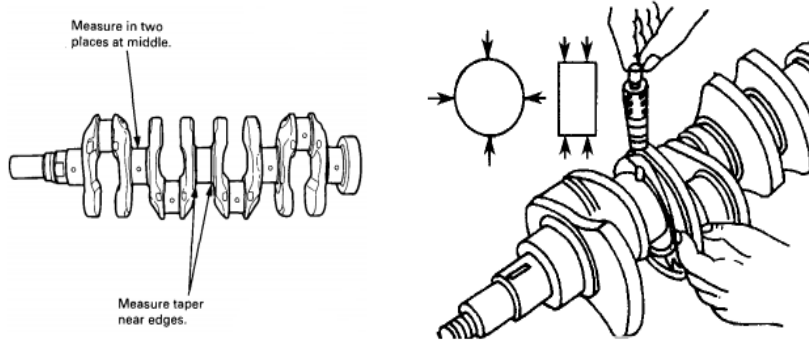
Fig. 13 Measurement of crankshaft main journal diameter and clearance [7]

Main journal diameter (mm)	1	2	3	4	5	Standard
A	49.99	49.98	49.97	49.99	50.00	Journal 1.4 49.984 50.008
B	49.995	49.985	49.975	49.99	49.99	Journal 2 49.976 50.000
Taper AB	0.005	0.005	0.005	0	0.01	Journal 3 49.972 49.996
						Journal 5 49.988 50.012

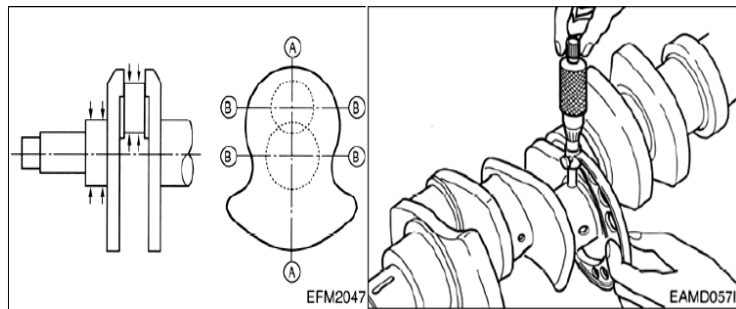
Fig. 14 Measurement of connecting rod journal and clearance [7]

connecting rod journal (mm)	1	2	3	4	standard
A	44.985	44.99	44.985	44.99	44.976~45.000
B	44.985	44.985	44.985	44.985	
Taper AB	0	0.005	0	0.005

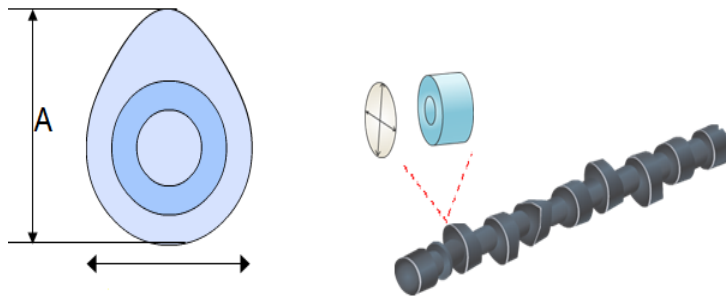
Fig. 15 Measurement of Camshaft height clearance [7]

Camshaft height (mm)	1	2	3	4	5	6	7	8	Standard
Intake A	38.70	38.71	38.72	38.72	38.72	38.71	38.72	38.73	38.741
B	33.42	33.40	33.41	33.40	33.40	33.41	33.41	33.42	
Exhaust A	38.96	38.96	38.95	38.95	38.96	38.96	38.96	38.96	38.972
B	34.04	34.05	34.04	34.035	34.035	34.035	34.035	34.04
