Structural Engineering Forensic Evaluation of Misdiagnosed Concrete Masonry Wall Cracking

W. C. Bracken

Keywords—Concrete masonry, masonry wall cracking, structural defect, structural damage, construction defect, forensic investigation.

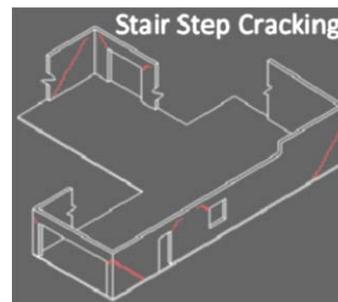
Fig. 1 Stair Step Crack Mapping

As previously discussed, the most common types of cracking manifest consist of stair step mortar joint cracking, horizontal joint cracking and vertical cracking. For purposes of analysis it is often helpful to map the locations and configurations of the cracking observed. This mapping serves to record the configuration, orientation and extent of propagation of the cracks manifest. See Figs. 1 and 2 for examples of crack mapping showing the types and common locations of cracking.

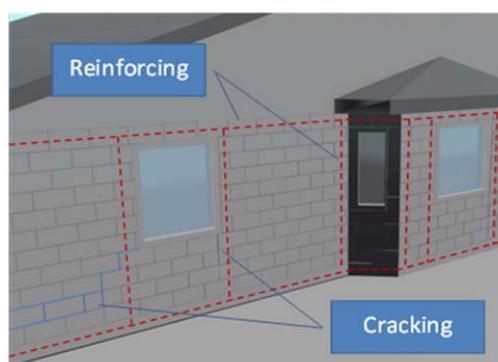
Fig. 3 As-observed by engineer #2

The [structure] exhibited signs of widespread negligible (hairline) to very slight (~ 1/32") masonry cracking. The majority of this cracking is the result of differential settlement of the foundation [shown in Fig. 3].

The location of vertically-orientated rebar/concrete filled masonry block cells were identified and found to be on either side of every opening and at a maximum spacing of 8 feet within the field of the walls [shown in Fig. 3].

Clearly, based on the fact pattern as presented, Engineer #2 has failed to consider the impact of anticipated cracking as the cause of the negligible, non-structural “hairline” to “very slight” ($< 1/32$ " or 0.8 mm) masonry cracking observed. In addition, Engineer #2 neglected to consider the full impact of the reinforcing within the wall.

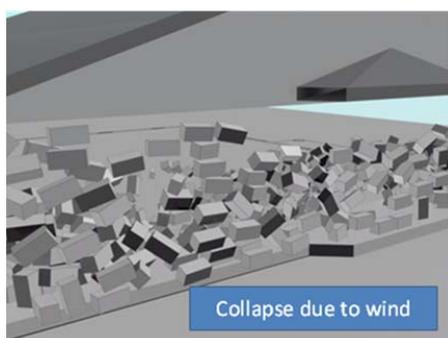
Fig. 4 Failure as theorized by Engineer #2

- 2) During the wind load case, considering that both uplift axial and out-of-plane bending forces must be transferred and resisted by the masonry structural components (masonry, mortar and the bond between the two) at the same time, the uplift counteracts the gravity loads limiting the flexural capacity gained by self-weight and dead load. Therefore, a wall segment that has been weakened by consecutive settlement related cracks may not adequately resist the building code mandated out-of-plane loads resulting in the failure shown in Fig. 4.

In other words, Engineer #2 opined that when the wind blows the wall will fall down based on the following:

- 3) When the wind blows it will generate sufficient uplift to “lift the roof” off its supporting walls and relieve all axial loads,
- 4) Because the wall has cracks, it is incapable of resisting out-of-plane bending,
- 5) With no axial load to resist bending, the cracking will allow the wind to blow the wall down, and
- 6) If the wall cannot resist wind loads, it is structurally compromised.

This failure to consider causes other than differential settlement, combined with a failure to consider the impact of the reinforcing, combined with a failure to perform any computational analysis in support of the opinion, resulted in a catastrophically flawed analysis which was used to promote and prolong litigation. Furthermore, continued failure to consider anticipated causes of cracking within concrete masonry walls combined with a failure to perform a proper analysis, will only continue to result in or be used to support litigation.
