Design and Construction Validation of Pile Performance through High Strain Pile Dynamic Tests for both Contiguous Flight Auger and Drilled Displacement Piles

S. Pirrello

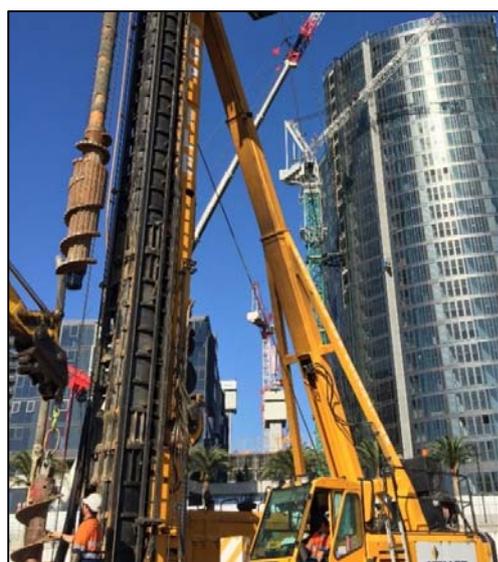
Fig. 7 Keller's modified DD drilling head

effort was made to reduce the volume of spoil generated by piling. A displacement auger capable of drilling through thicker layers of stiff clay and founding in the rock extends the chances of its applications within this site. Fig. 7 shows the modified DD head custom made for this site.

The DD head adopted was a hybrid of the Omega and De Waal heads, utilizing an “Omega-type” head with a 3-m to 6-m auger extension. This guaranteed extending the application of the DD piles within layers up to 6 m of Unit C, while still delivering the required designed minimum pile sockets of up to 1-m length in the MS Sydney Sandstone. Pile design and settlement estimate were carried out in accordance with limit state procedures as outlined in the Australian Standard AS2159-2009 [1], which requires piles to fulfil both serviceability and strength requirements. The geotechnical reduction factor adopted for low and high redundancy piles was 0.65 and 0.71, respectively. The foundation design for this project comprised the design and construction of over 800 piles, the final scheme comprising 55% CFA piles and 45% DD. Pile diameters were 600 mm and 750 mm, with all piles being socketed up to 1 m into MS Sandstone to meet design requirements. The proposed development extends to an area greater than 24 football fields. Different design zones were developed, targeting any significant variability of the soil and bedrock profile. Differences such as thicknesses of soft soil (i.e. Unit B), Unit C, and levels of the MS Sandstone had to be assessed and considered in the design. A typical geotechnical soil profile for this site is presented in Table I.
