Non-Destructive Evaluation of Launch Tube Welds with Radiography

Abstract—The non-destructive testing of launch tube weld with radiography was investigated and evaluated with AWS D1.1 standard. The paper started with preparation of launch tube and radiographic inspection. X-Ray inspection then was done and gotten the result. The judgment of inspection results were concluded by certified person and finally, the evaluation with AWS D1.1 standard was conducted as well.

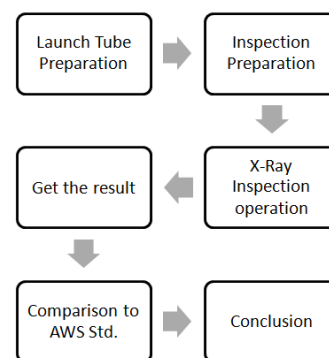
Fig. 1 shown research methodology

The research methodology was first applied by preparation of launch tube and inspection equipment, X-Ray Inspection. The operations for inspection with X-Ray then carried out for example marked inspection date/number, stuck IQI on film, attached of film and radiation source on launch tube, etc. Weld images would be occurred on X-Ray film and then primary judged for quality and qualify of each weld by certified body. The comparative evaluation according to AWS D1.1 had been obtained on next stage which would be secondary judged for decision which welds have to rework.
