Non-Destructive Evaluation of Launch Tube Welds with Radiography

Tosapolporn Pornpibunsompop

Abstract—The non-destructive testing of launch tube weld with radiography was investigated and evaluated with AWS D1.1 standard. The paper started with preparation of launch tube and radiographic inspection. X-Ray inspection then was done and gotten the result. The judgment of inspection results were concluded by certified person and finally, the evaluation with AWS D1.1 standard was conducted as well.

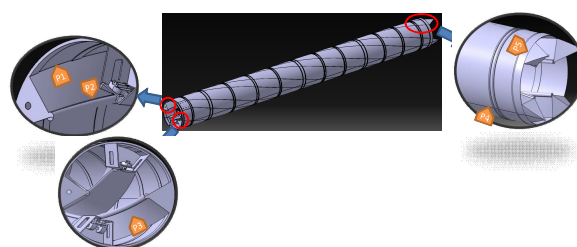
Fig. 2 Inspection position on launch tube

Inspection position: The position is shown in Fig.2

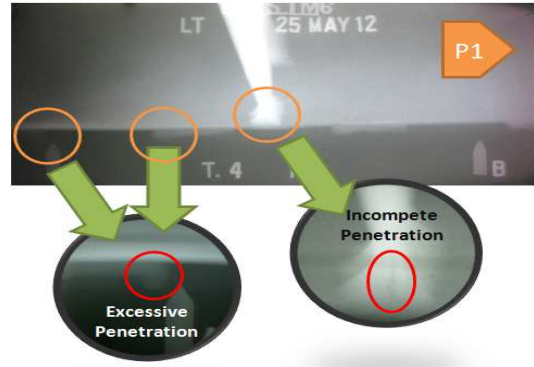
Fig. 3 Inspection result of position P1

No.	Position	Defect	Size	AWS D1.1	Evaluation
1	P1 weld size 5 mm.	EP	1 mm. in length	2 mm. max	Conform
		IP	4 mm. in length	4 mm. max	Non-Conform
2	P2 weld size 5 mm.	P	1 mm. in dia.	2 mm. max	Conform
3	P3 weld size 5 mm.	Found nothing	-	-	Conform
4	P4 weld size 5 mm.	Found nothing	-	-	Conform
5	P5 weld size 5 mm.	P	1 mm. in dia.	2 mm. max	Conform

The weld position P1 contains IP size about 4 mm. AWS D1.1 allows weld discontinuity in case of weld size 5 mm. not exceed 4 mm. in size. Generally, this weld position conforms to standard however, it is marginal accepted and position P1 plays a vital characteristic because it reinforces rail support and will be loaded with impact in service. Consequently, weld position P1 has been rejected and needing corrective action such as removing obsolete weld bead, re-welding, and then inspection again.

This paper studied non-destructive inspection, judgment, and evaluation of launch tube's weld. The judgment of weld performed by certified NDT at least RT level II person. AWS D1.1 had been adopted to assess which welds conformed. The discussion case was weld position P1 which decided as marginal accept because it relied on lower bound of AWS standard. However, P1 could not accept due to it impacted to efficiency of launch tube.
